# Town of Brunswick, Maine

### DRAFT FINDINGS OF FACT REQUEST FOR CERTIFICATE OF APPROPRIATENESS FOR ADDITIONS AND ALTERATIONS VILLAGE REVIEW BOARD

**PROJECT NAME:** 9 Cleaveland Street; Pilgrim House Rooftop Solar

**CASE NUMBER:** VRB 25-014

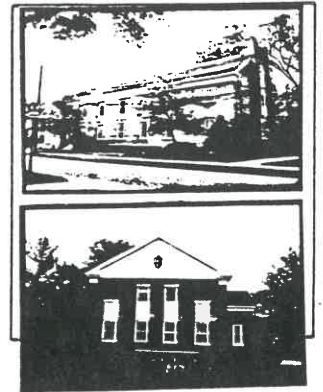
1980 photos J. Goff

Historic Significance to the Community: Earlier building on site was late 19th c. mansard roofed structure (1874 Ridley & Stanwood store?). See photo on reverse. Another structure on site previously was early Greek Revival double house 9/11 Cleaveland (see photos).

Re present building: see Brunswick Record 11/24/1955, cornerstone laid.  
Brunswick Record 5/17/1956 "nears completion"

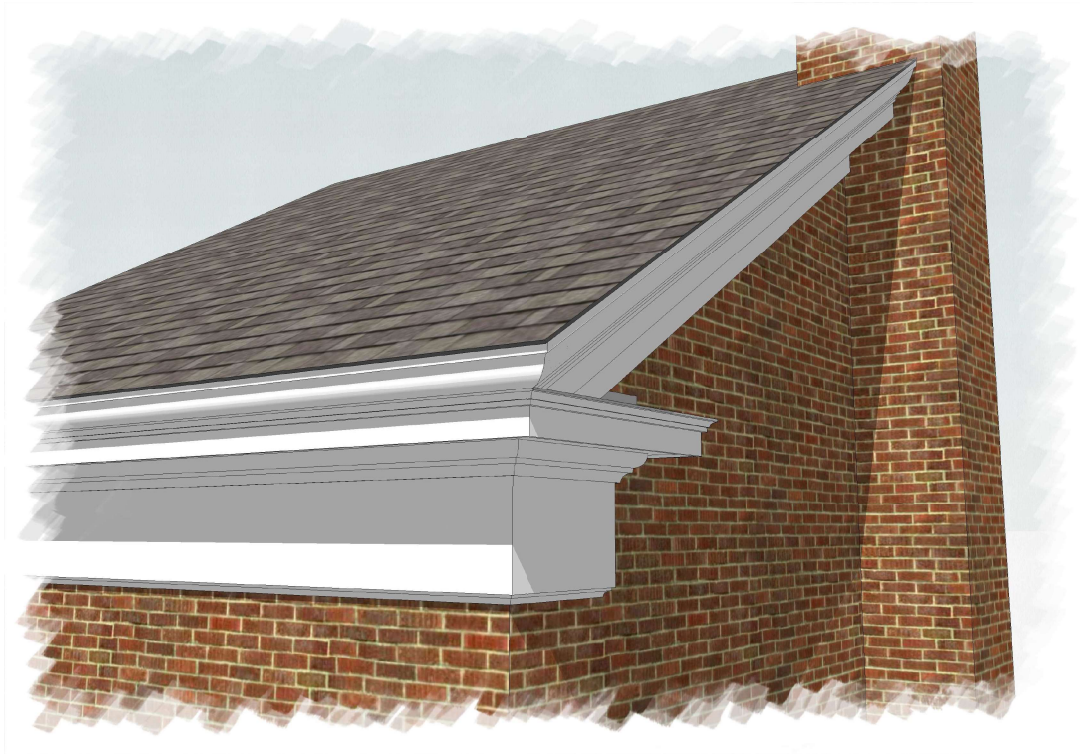
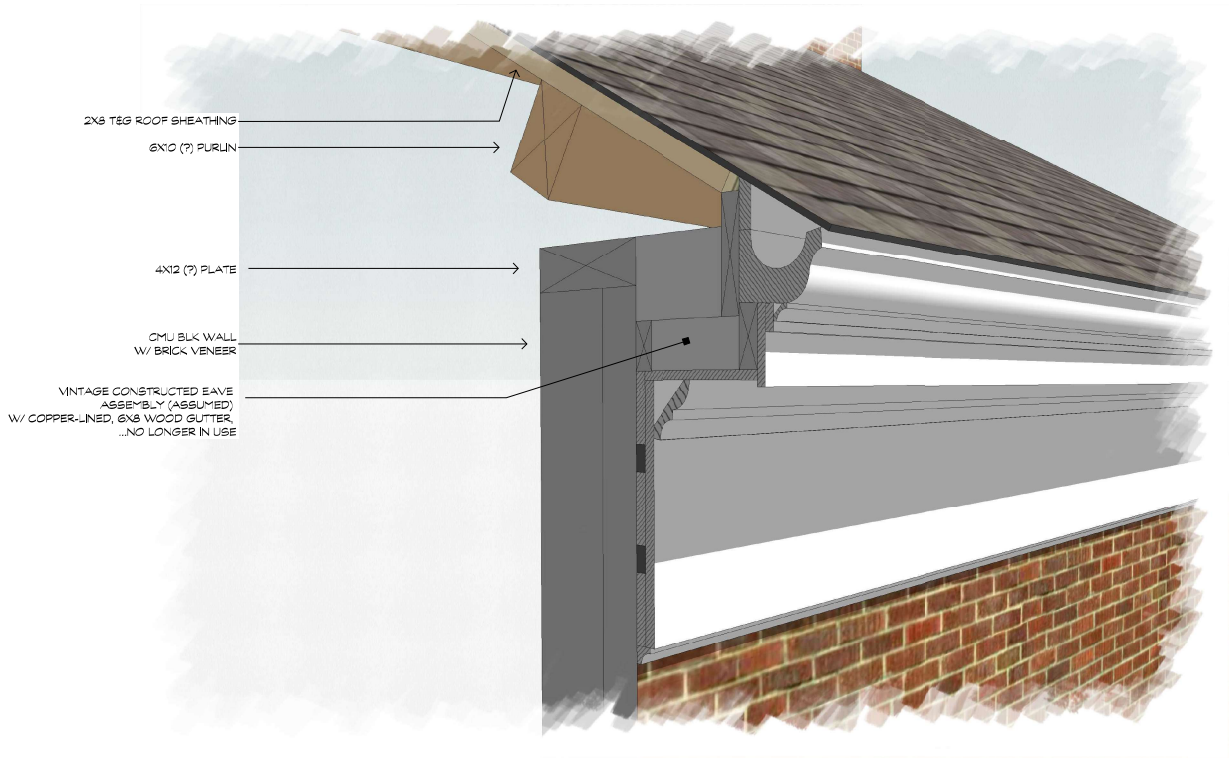
EXISTING, TYP.

NOTES:  
1. PERSPECTIVES SHOW ADDITIONAL ROOF TRIM REQD. TO ACCOMMODATE THE ADDITION OF 5'-6" POLYISO INSULATION APPLIED TO ROOF EXTERIOR SURFACE IN CONJUNCTION WITH ROOFING REPLACEMENT, AND PRIOR TO ROOF-MOUNT SOLAR PANEL INSTALLATION.  
2. PERSPECTIVES ARE NOT SCALABLE.

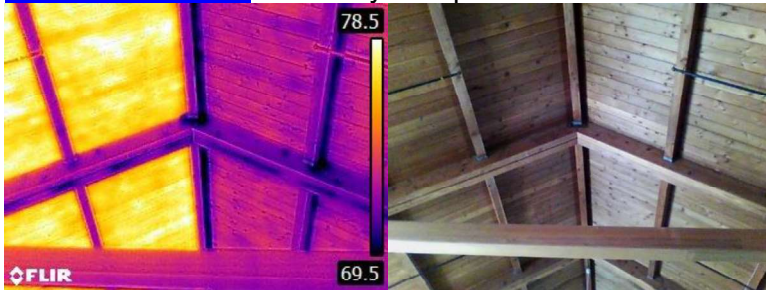
- (H) Install rigid foam board insulation on the roof deck as part of the roofing replacement. Ideally, a minimum R-value of 49 would be achieved though this may not be realistic. Install either polyisocyanurate or polystyrene insulation with staggered horizontal and vertical joints if more than one layer of insulation is installed. An air barrier membrane must be installed between the existing tongue and groove roof deck and the insulation. Make sure all seams are sealed. The use of a fully-adhered membrane is recommended. For a good representation of the insulation detail, review Figure 5 in [BSI-046: Dam Ice Dam](#) written by Joseph Lstiburek.

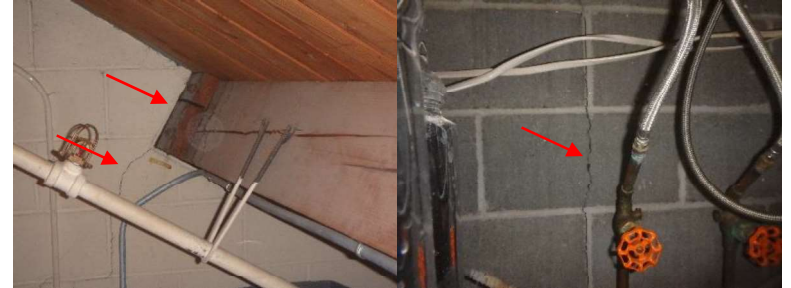
- (H) **Safety** At 145° F, domestic hot water temperature was above the safe maximum temperature of 120° F at the kitchen sink. Adjust the temperature using the thermostat at the top of the water heater.
- (H) If the upper floor is not typically occupied during the week, consider lowering the thermostat (approximately 5-8 degrees below its typical occupied set point) for this area (if it is not done so already).
- (H) Air leakage appeared to be occurring at the purlin/exterior wall junctures. Air seal the perimeter of the purlins using high quality flexible sealant. Also seal the vertical cracks observed in the exterior walls including below the kitchen sink and near roof juncture.

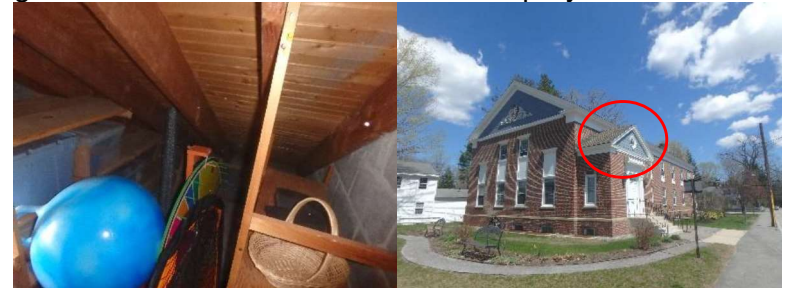
- (H) The attic space above the southwest entrance was not insulated. It is recommended that the underside of the roof deck be insulated using 6 inches of closed cell spray foam. Current standards may require that the insulation be covered with a thermal barrier such as intumescent paint. Insulate the gable wall with 3 inches of closed cell spray foam as well.

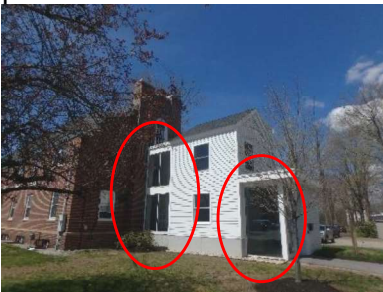
- (H) There was significant solar heat gain occurring at the east entrance addition during the site visit. Consider installing overhangs above the windows at the exterior to reduce solar heat gain during the warmer months. Click [here](#) for an explanation of the benefits of overhangs and [here](#) for potential products.

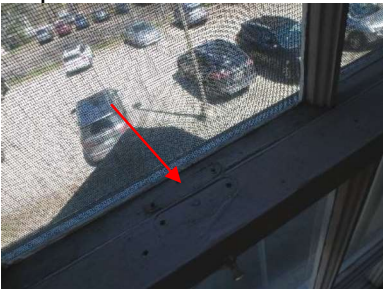
- (H) Sash locks were missing from a couple of windows. Replace. Will reduce air leakage.

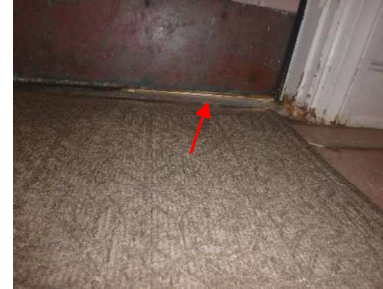
- (H) Replace worn sweepers and weather-stripping at the original exterior wood doors to reduce air leakage.

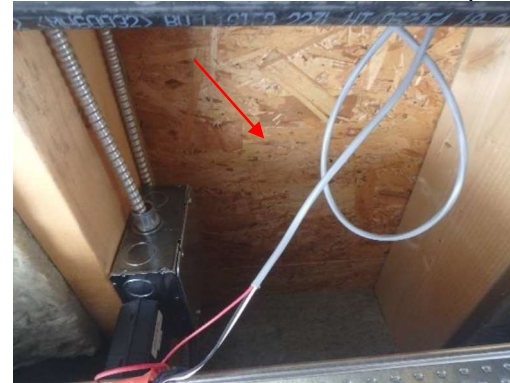
- (H) Insulation was missing from between roof rafters beneath flat roof section of the addition. Replace.

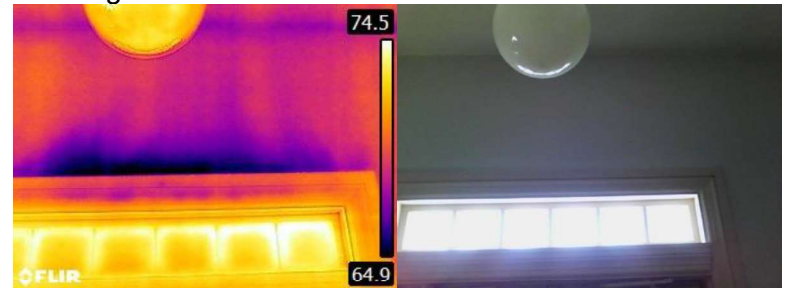
- (M) Air leakage was observed above the transom window at the southeast entrance. Air seal the wall/trim juncture using caulking.
