DESIGN GUIDELINES

Village Review Overlay District

Adopted by Town of Brunswick Town Council on July 6, 2020

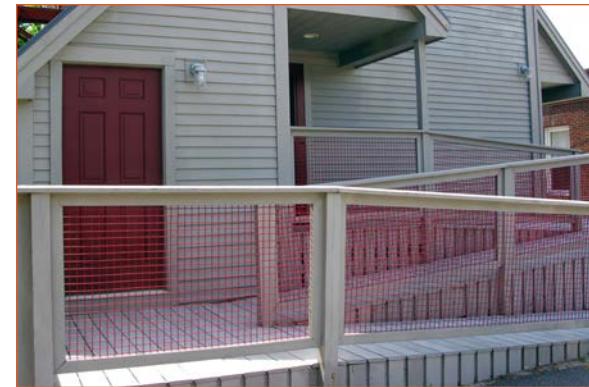
Located at the rear entrance of this building on Maine Street, the ADA-compliant ramp above promotes independence for the disabled person while preserving the primary façade and other significant historic features of the building. Although the ramp below is attached to the primary façade, its design is compatible with the existing porch, balustrades, and handrails.

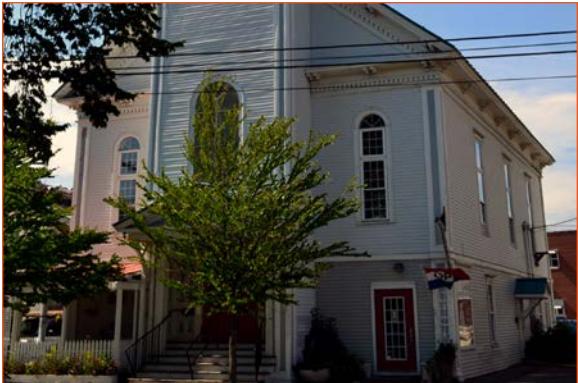
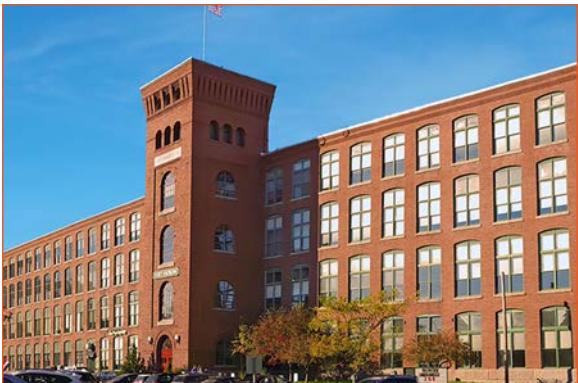
Rather than demolishing a building, adaptive reuse allows for the repurposing of vacant buildings such as this former church (above) on Pleasant Street that is now a wine bar and fabric store. The Fort Andross Mill Complex¹ (below) is another example of adaptive reuse. The former mill is now a mixed-use building with retail, office, restaurant, and entertainment uses.

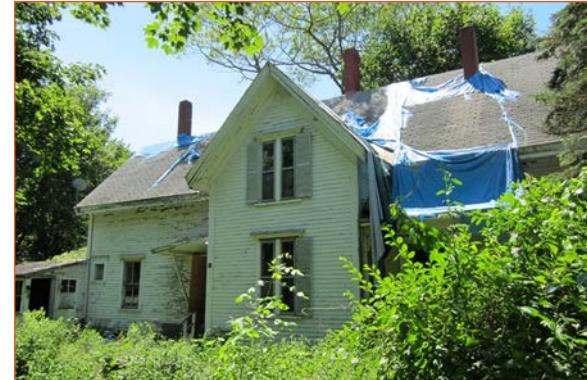
An example of a building that used to be on Pleasant Street that experienced demolition by neglect and had to be torn down in 2011.

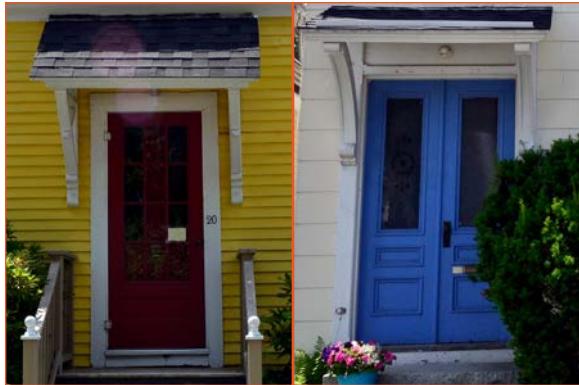
Both single- and double-doors are found throughout the VRO. It is common for these doors to have wood panels on the lower half, glass panels on the upper half, and a pediment over the doorway.

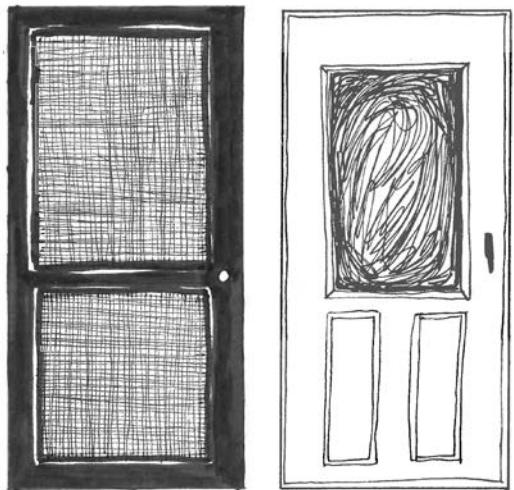
Caution should be used when selecting a storm door to prevent such an important character-defining feature from being damaged or hidden from view. In the above example the upper glass panel and lower wood door panels will not be obscured by the storm door.

9. Storm doors should be compatible with the existing door in material and color. Storm doors should be mounted so that they will not permanently damage the original door surround and trim. Storm doors should be designed in such a way that they do not completely obscure the historic door.
10. The character of an entrance should not be altered by either the removal or addition of historic elements that never existed on the property.
11. Paired or double doors should not be replaced with a single door or vice versa.
12. Exterior lighting fixtures should be mounted in a manner that does not obscure or damage the door surround.

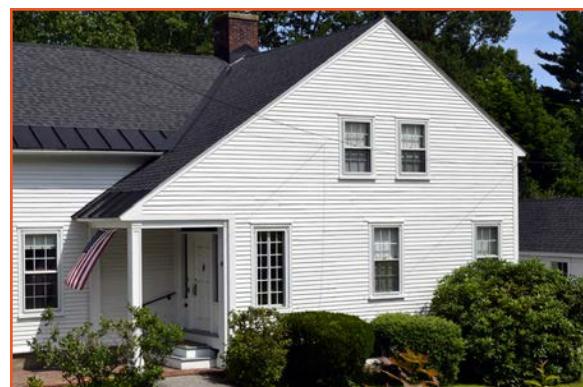
This home on Federal Street is an example of wood clapboards aligning cleanly with the top and bottom edge of the windows.

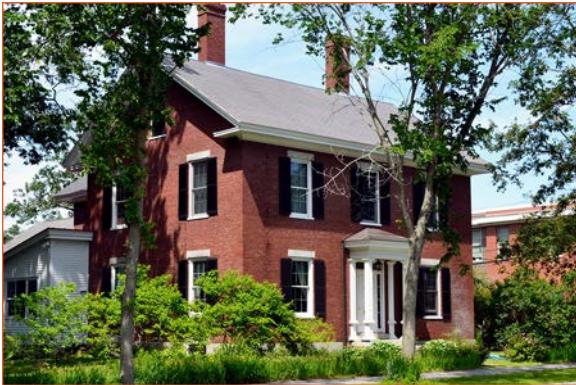
Although most buildings within the VRO District were originally constructed with wood clapboard siding, there are a few historic masonry structures, like this brick home on Federal Street. For more information on the maintenance of historic masonry buildings, visit:

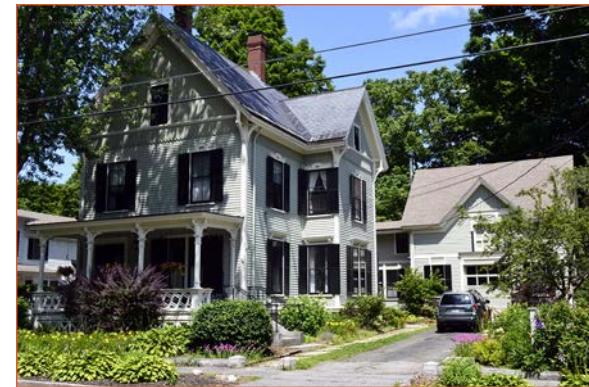
Some buildings like the stick-style building above on Cumberland Street, utilize both horizontally- (1st and 2nd floors) and vertically-oriented (gable end of the home and garage) siding.

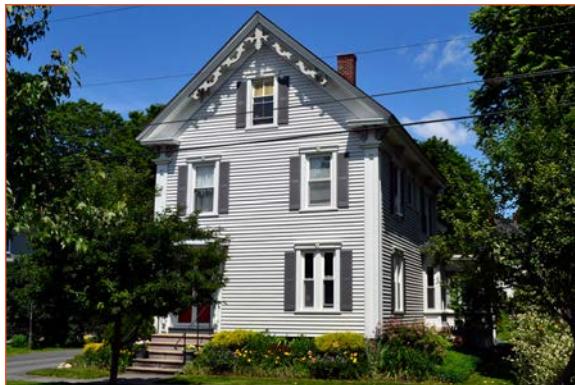
Covering wood clapboards with a substitute material like vinyl or aluminum may substantially reduce the depth between the exterior wall plane and decorative trim. As seen on this house on Cumberland Street, the depth between the original wood clapboards and the decorative trim creates shadows that enhance the character of a building.

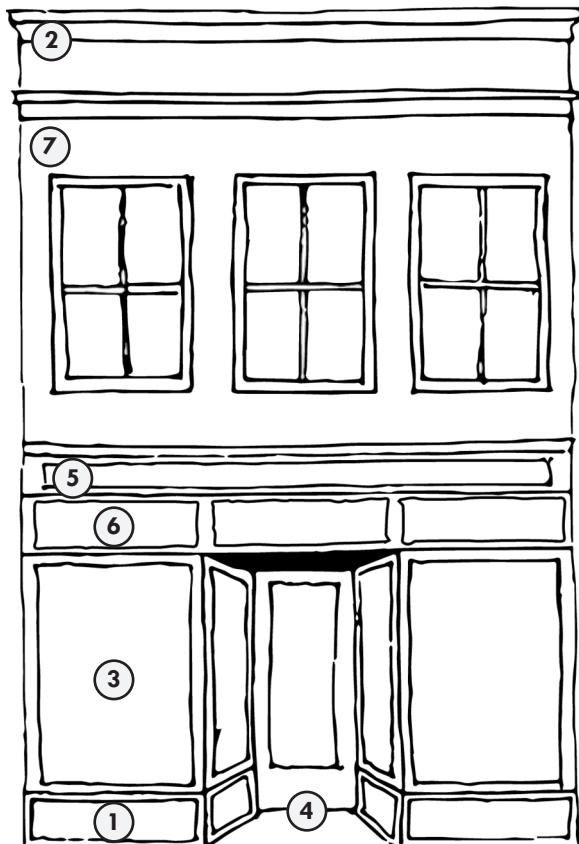
1. Bulkhead
2. Cornice
3. Display Window
4. Recessed Entrance
5. Sign Band
6. Transom / Clerestory Window
7. Upper Façade

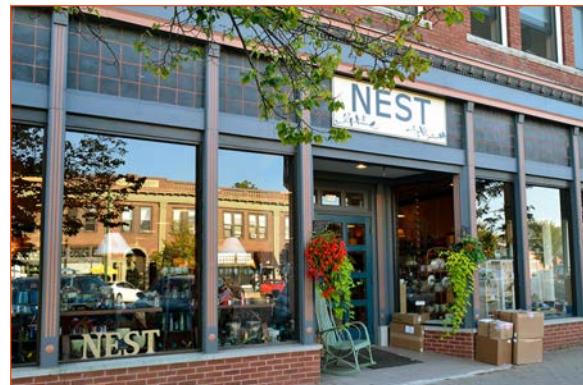
The well-maintained storefront elements (bulkheads, display windows, transoms) on the Lincoln Building on Maine Street contribute to its status on the National Register of Historic Places.

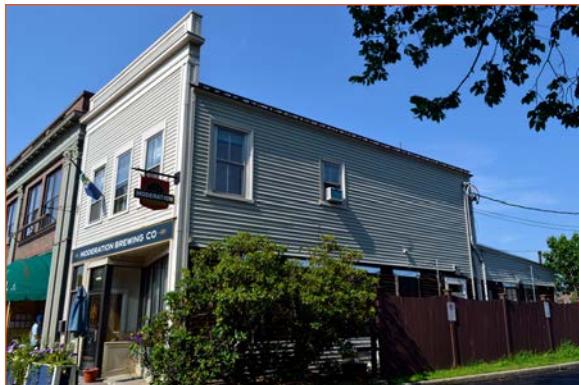
This building on Maine Street has a parapet and false front.

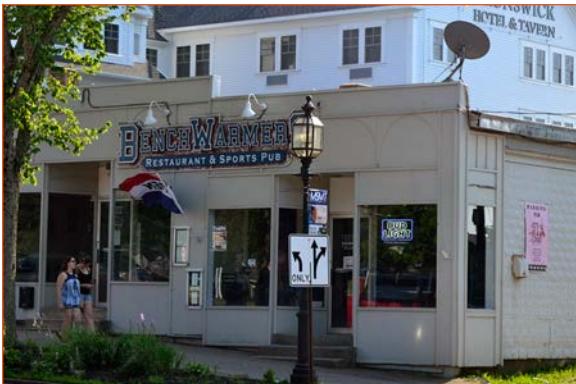
Concealing or locating the rooftop satellite dish away from the primary façade would better maintain the building's character.

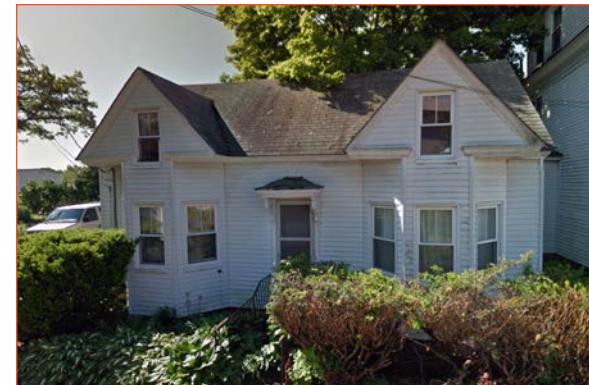
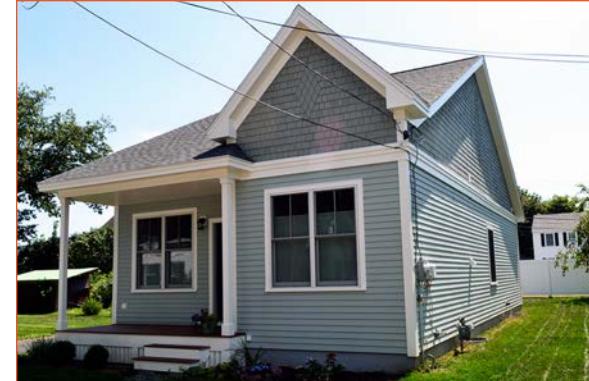
This previously existing home on School Street (above) was demolished and replaced with a new home (below) that is visually compatible with the mass, scale, and materials of the surrounding neighborhood

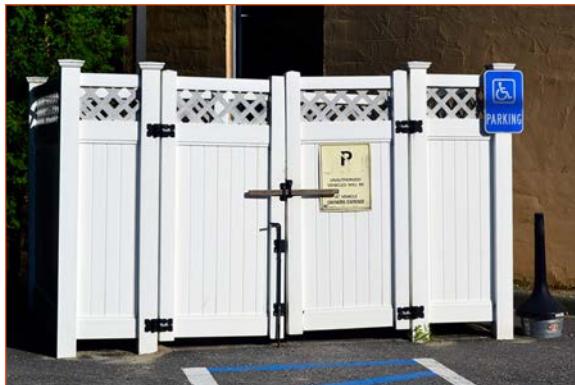
The Brunswick Zoning Ordinance requires dumpsters to be screened from public view. Cigarette receptacles are not required, but businesses are encouraged to provide them for their staff.

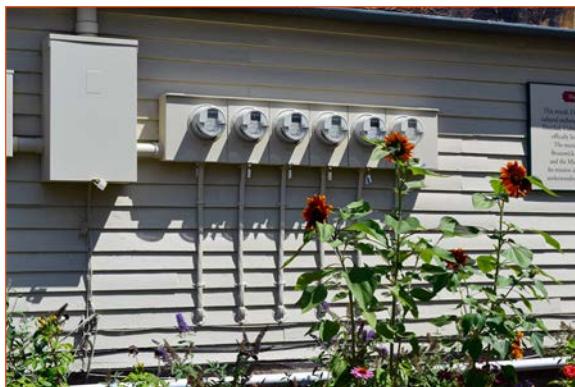
Painting equipment such as utility meters and planting attractive landscaping is one way simple method to screen mechanical equipment.

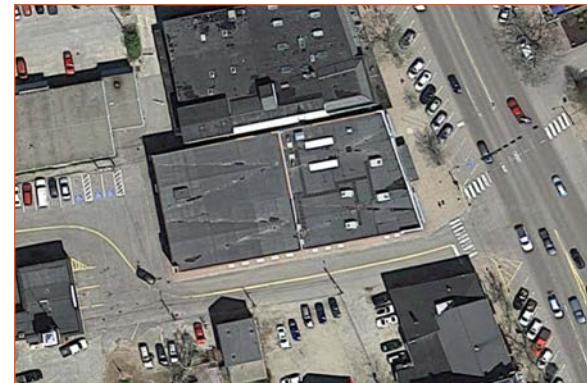
A significant remodel provided an opportunity for this Maine Street business to relocate HVAC equipment to the roof, screened from public view.

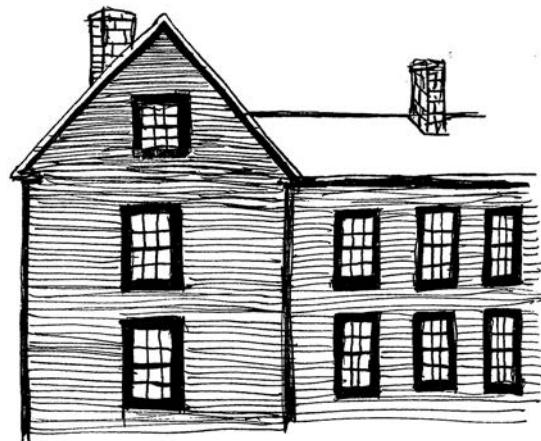
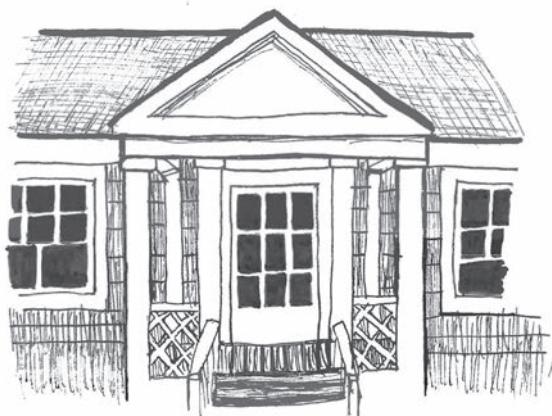
Ells (above) and pediments (below) are common additions to historic buildings that have taken on their own architectural significance.

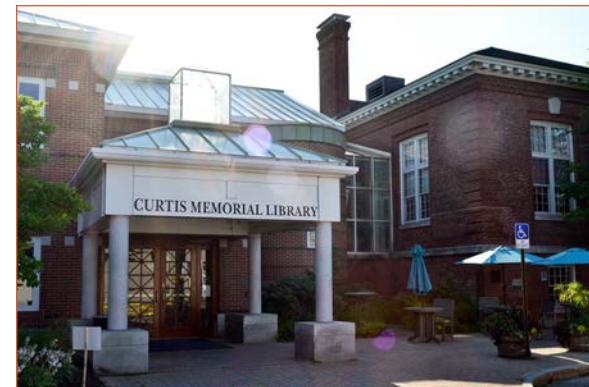
The addition (left side of image) to the existing (right side of image) Curtis Memorial Library is an example of an addition that is distinct from, but compatible with the style and materials of the existing building

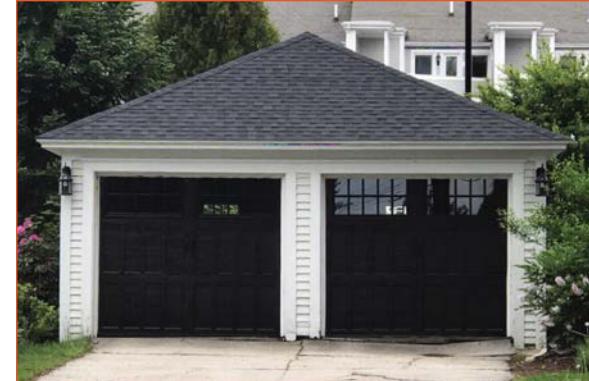
Single- or double-row glass panes are a common architectural elements on historic outbuildings.

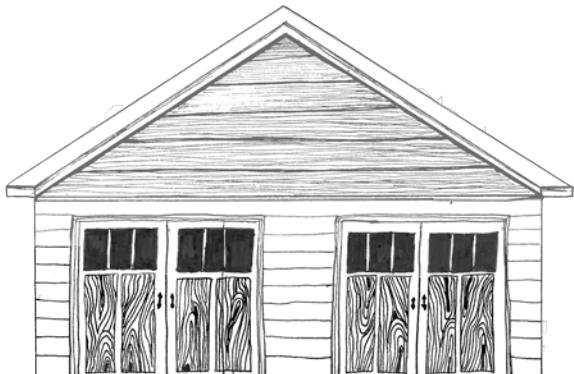
The reuse of existing openings and single-width garage doors (above) are always preferable to double- (below) or triple-width doors.

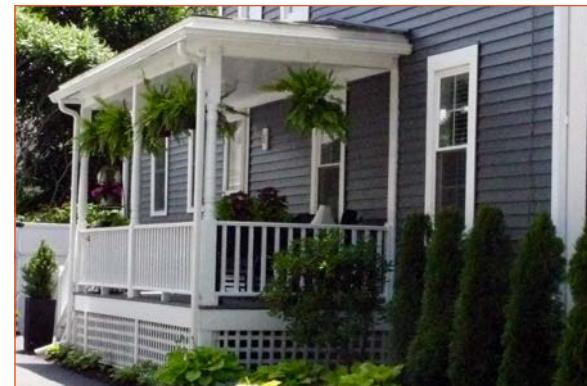
This one-story attached side porch demonstrates the opportunities available for architectural expression that is also compatible with the principal building.

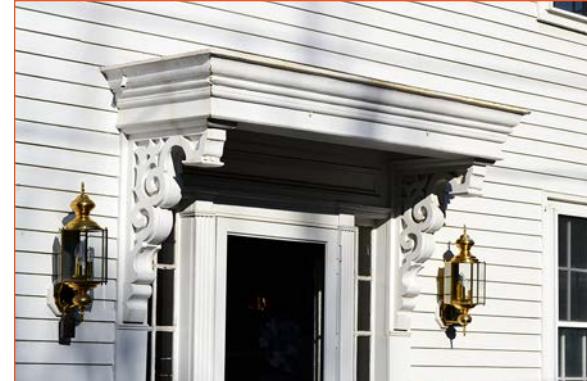
Small roof pediments with decorative brackets were common additions to Federal and Greek Revival style houses.

The majority of Federal and Greek Revival style houses in Brunswick did not originally have entry porches; however, porches were often added to these houses. There are many properties with a small roof pediment over the main entry, which is supported by decorative brackets. This detail was common during the mid-to-late 1800s and is characteristic of the Italianate style.

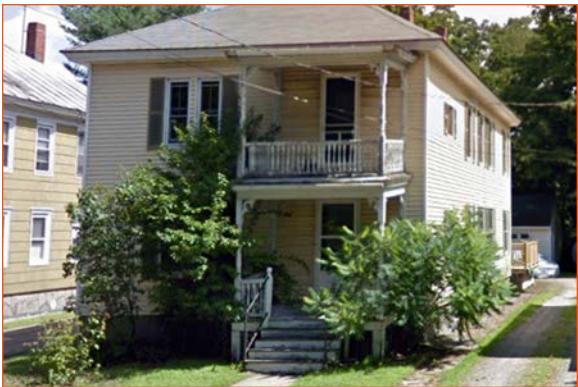
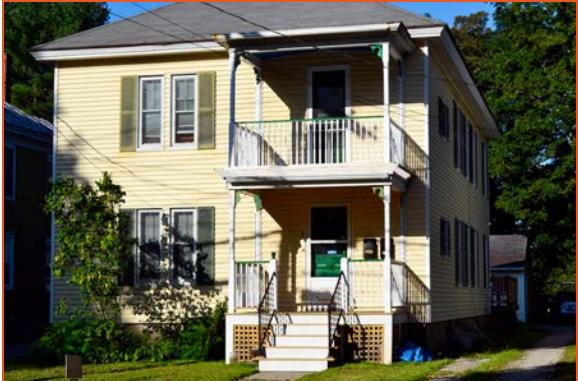
A dilapidated porch (above) on Federal Street was demolished and replaced with a new porch (below) with the same material, scale, shape, and detail, including decorative brackets.

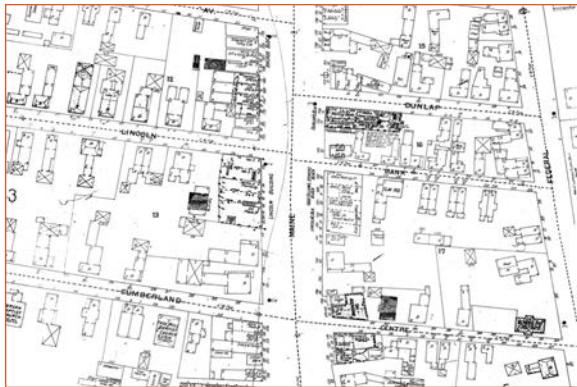
This map from 1901 illustrates some of the various development patterns within the VRO District: Maine Street with its broad width and minimal front building setbacks, the moderate width and side setbacks of Lincoln and Cumberland Streets, and the narrow width and side setbacks of Bank and Centre Streets.

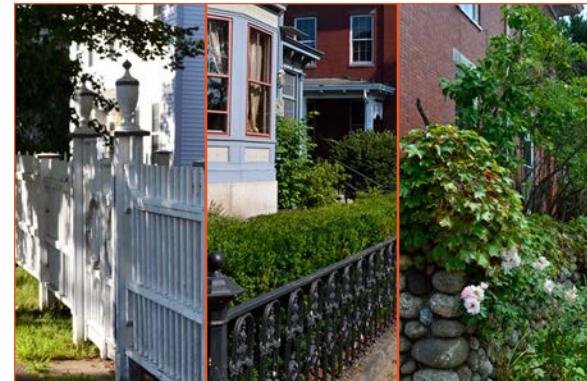
Wood (left), wrought iron (center), and stone (right) are the most commonly used fence materials in the VRO District.

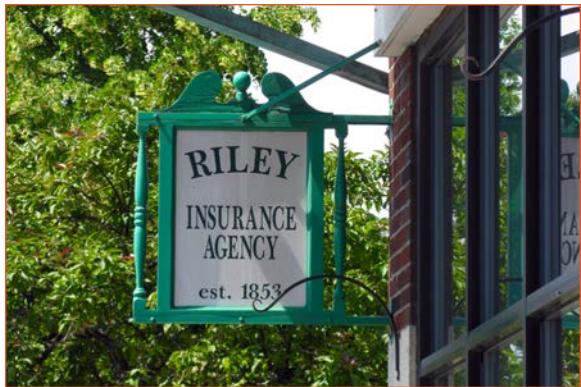
A projecting sign for a business on Maine Street.

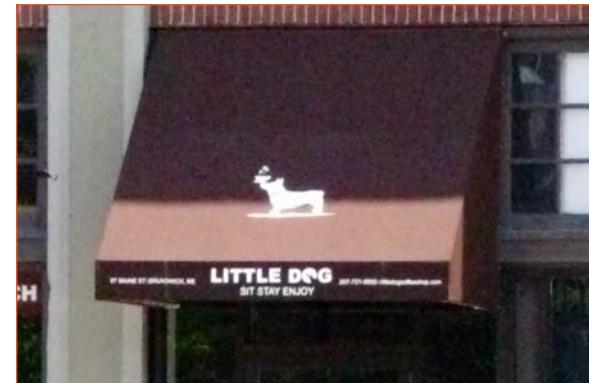
An awning for a business on Maine Street with signage on both the canopy (discouraged) and the valence (encouraged).

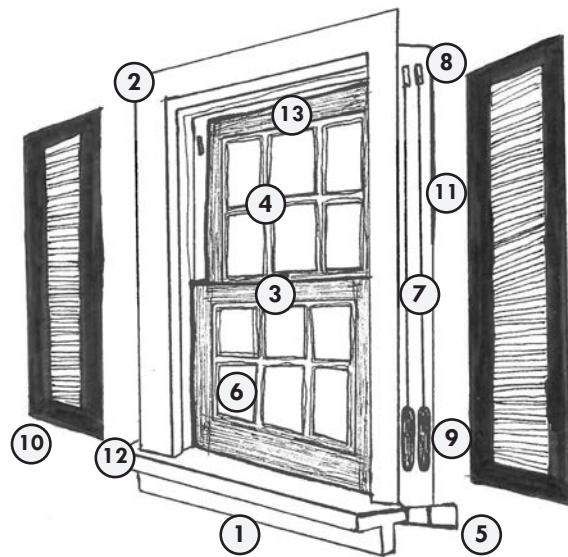
1. *Apron*
2. *Frame / Casing*
3. *Lower Sash*
4. *Muntin*
5. *Outer Sill*
6. *Pane*
7. *Sash Cords*
8. *Sash Pulleys*
9. *Sash Weights*
10. *Shutter (x2)*
11. *Side Jamb*
12. *Stool*
13. *Upper Sash*

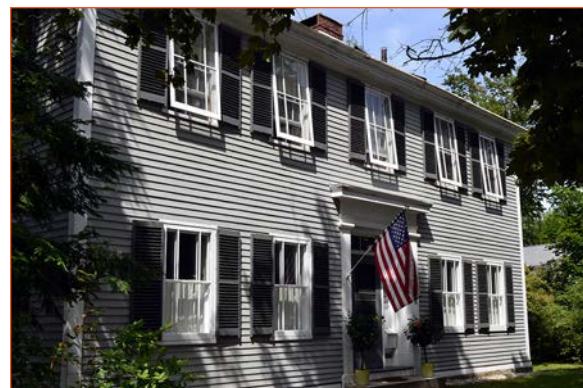
Storm windows like those on this home on Federal Street can maintain the historic character of a building and reduce heat loss.

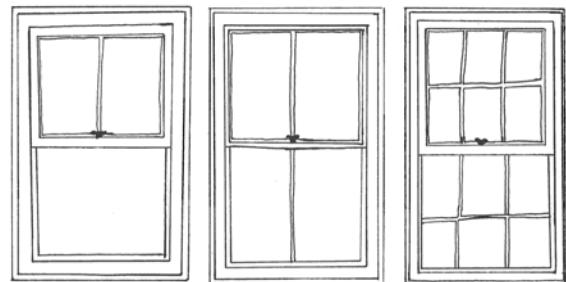
Although various other divided light patterns are located within the VRO District, two-over-one, two-over-two, and six-over-six are the most commonly used pattern.

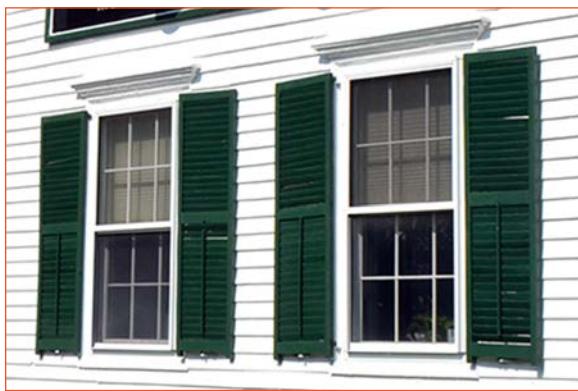
If maintained properly, original shutters (like those above located on a Park Row business), can make a significant contribution to the overall architectural character of a building. However, shutters should not be added to an existing building when there is no evidence they ever existed.

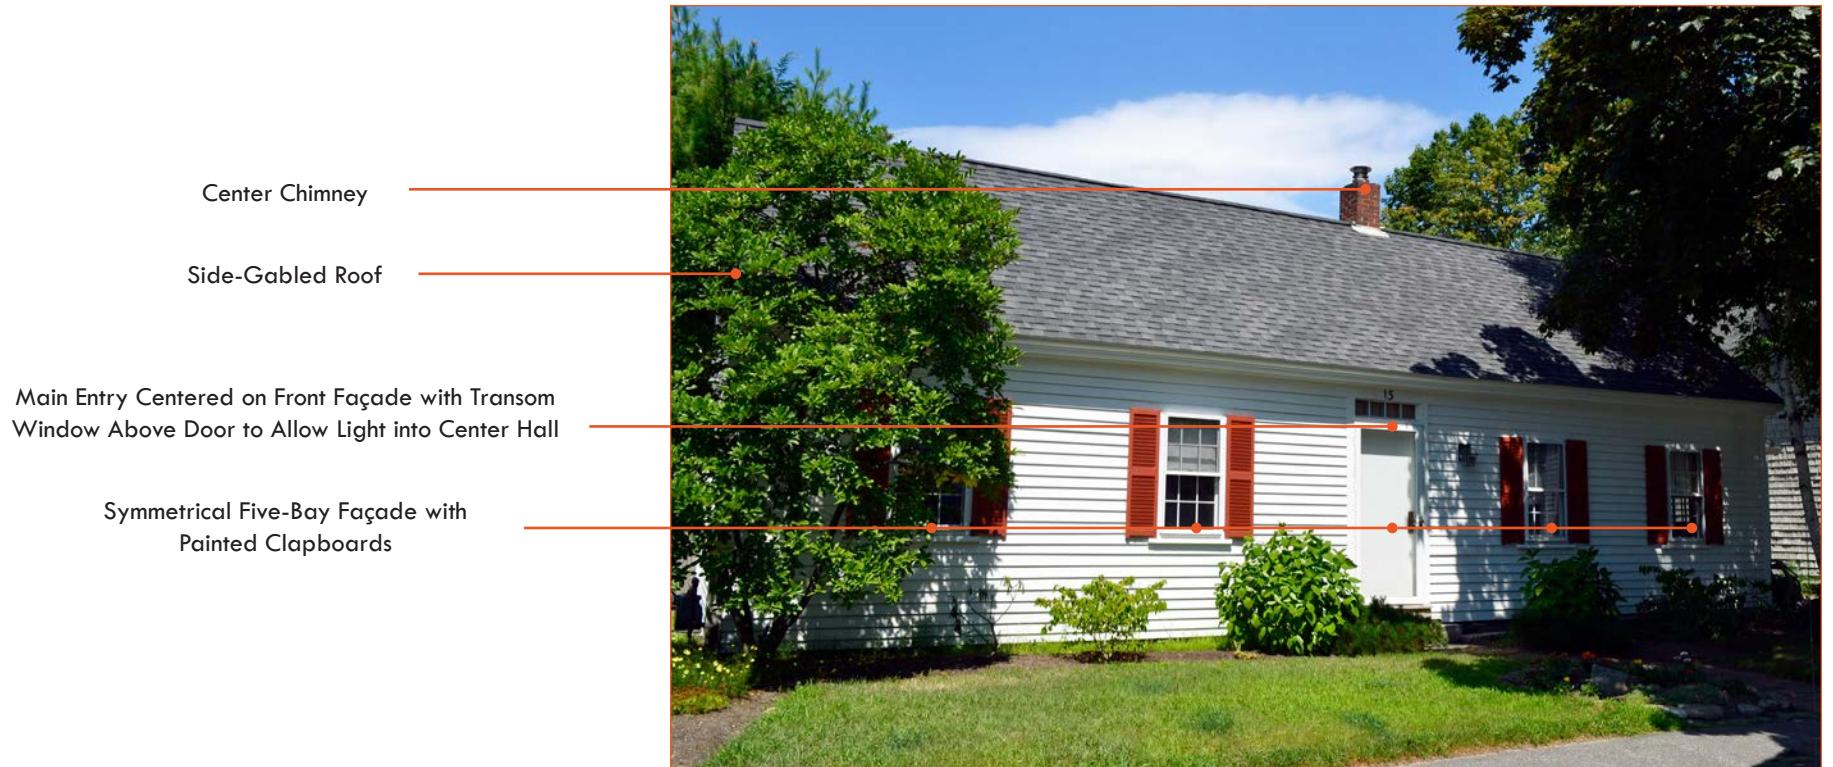
Although this Colonial-style house on School Street has six-over-six sashes, nine-over-six and eight-over-eight sashes were typical of the era.

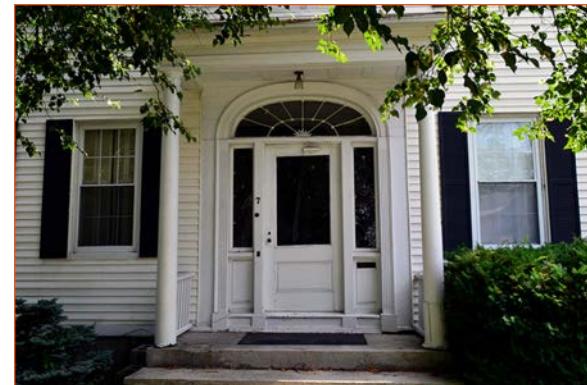
The main entrance of a Federal-style house is one of its defining features. This entrance on Federal Street has the characteristic elliptical fanlight, sidelights, pilasters, and a portico supported by narrow columns.

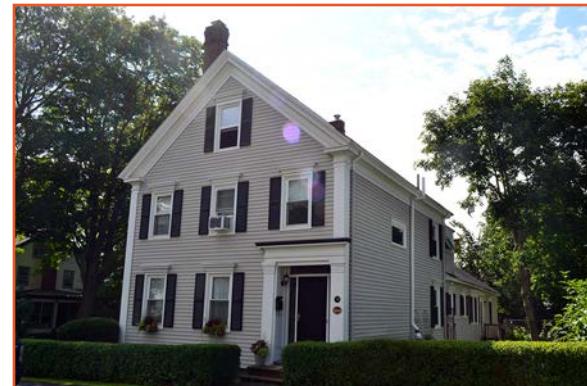
This residence on High Street features common Greek Revival architectural elements such as a side gable roof with a triangular pediment, corner boards, and a recessed entrance with a bold door surround.

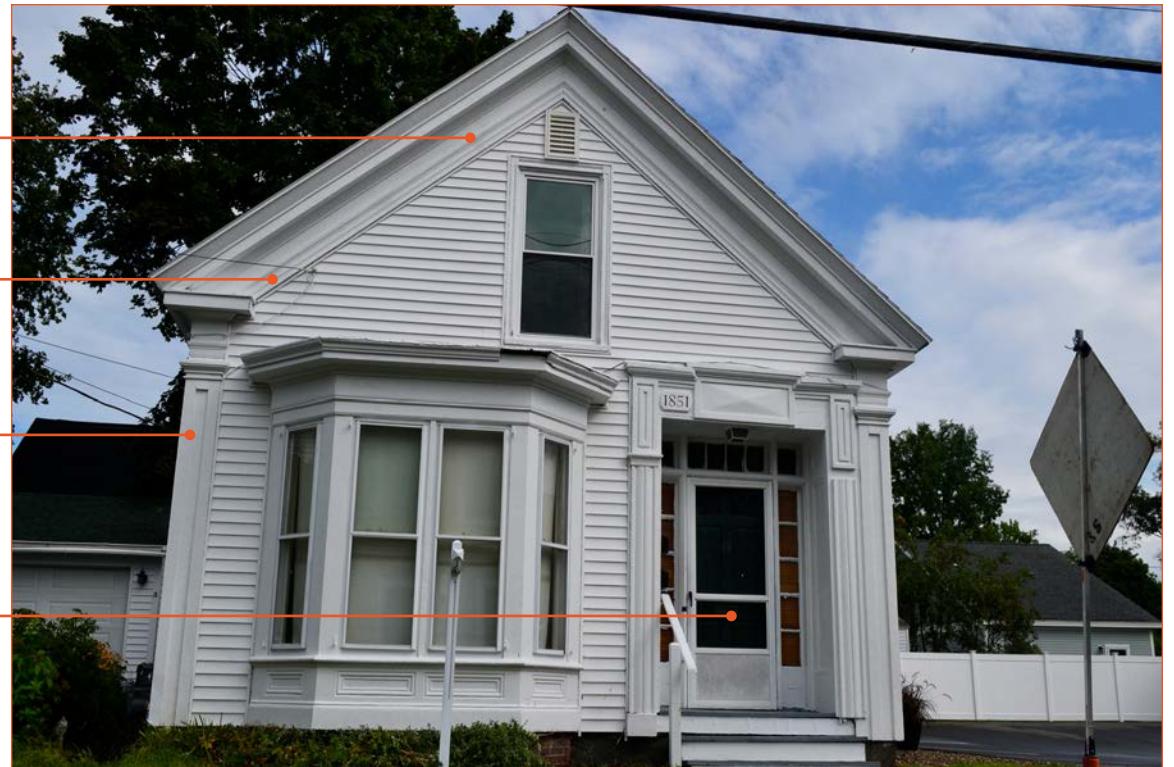
Main Entrance Recessed and with a
Rectangular Door Surround and
Rectangular Sidelights

(Greek Motifs such as a Greek Key or Fret Pattern Are Often Found
on Door Surrounds)

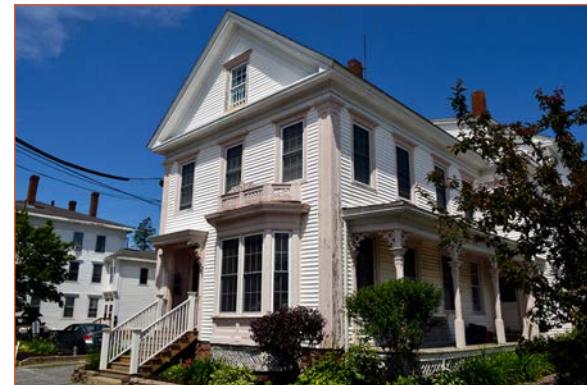
This house on Gilman Street is an example of a building with an earlier building, Greek Revival, updated with Italianate features such as decorative hoods over windows and a small pediment with brackets.

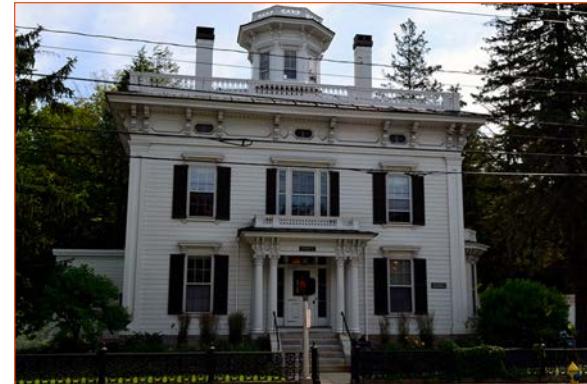
Towers are a common feature of high design Italianate buildings.

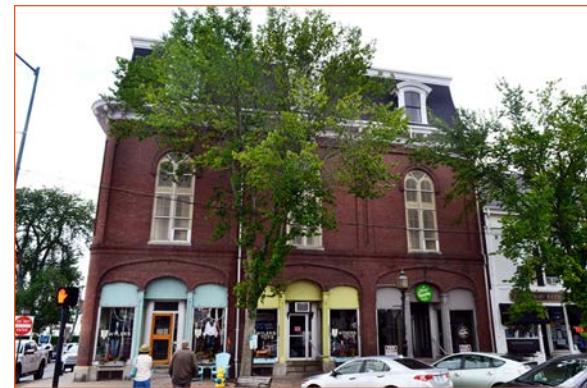
The Wyler Building on Maine Street, with its mansard roof with dormer windows, represents the essential architectural elements of a Second Empire building.

The primary defining characteristic of Second Empire is the mansard roof with dormer windows. The roof form became popular because it created a functional full height attic space. It was not uncommon to see the roof of an existing house converted to a mansard form in order to gain additional usable space. Dormers often have elaborate hoods or decorative surrounds. Additional character-defining details include molded cornices at the top and bottom of the roof slope, and decorative brackets at the eaves.

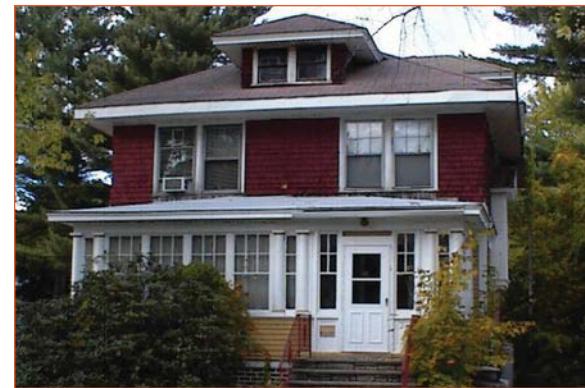
This Four Square residence features many of the architectural elements associated with the style: hipped roof with a hipped dormer, six-over-one window sashes, and an attached porch with the entry off to the side.

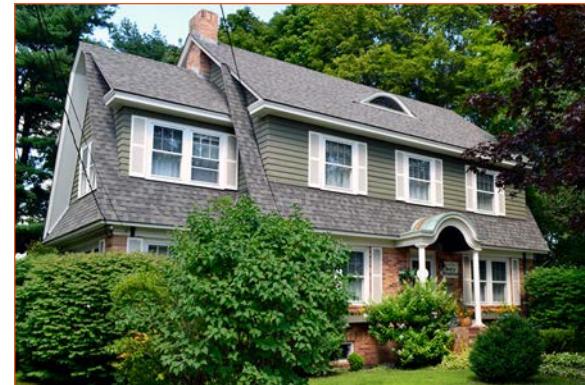
Although side gambrel roofs are most common for Dutch Colonial Revival, as is the case for this building on Pleasant Street, there are several front gambrel roofs within the VRO District.

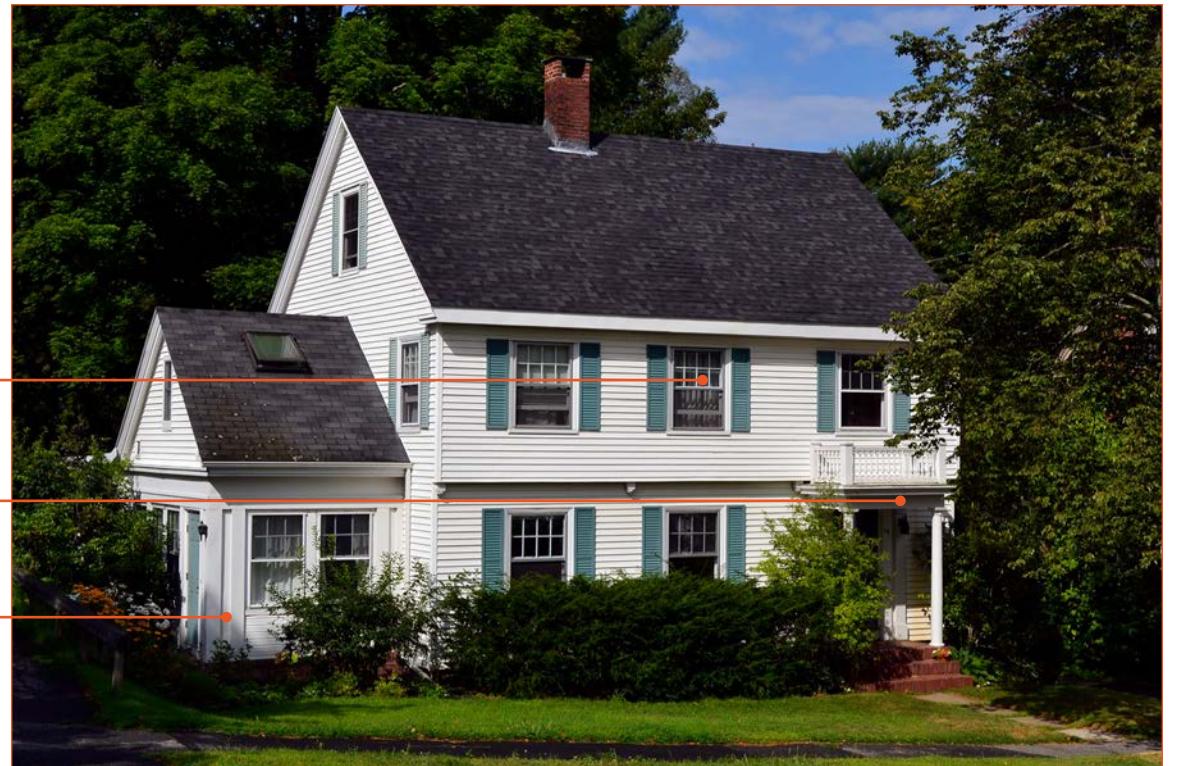
Windows are Wider than Earlier Styles

Entrance is Off-Center and the
Fencing above the Pediment is
not Characteristic of Earlier Styles

Side Porches are Characteristic of
the Colonial Revival Style

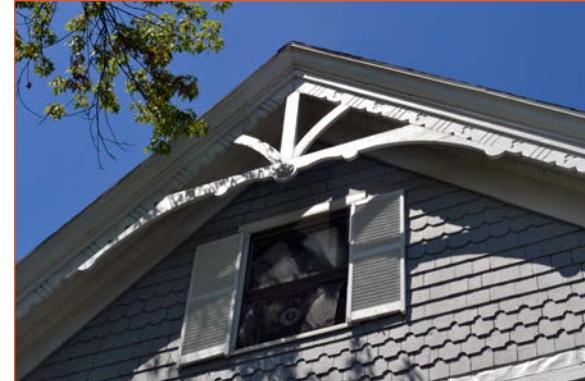
Stickwork like that above is intended to appear to be an integral part of a building's structure, but it is non-functional.

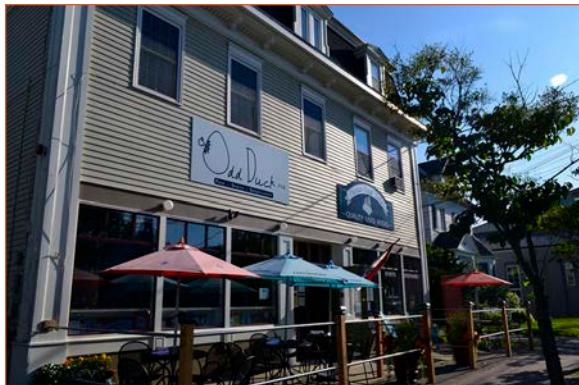
This Second Empire-style building is one of several buildings on Pleasant Street that have been converted for commercial use.

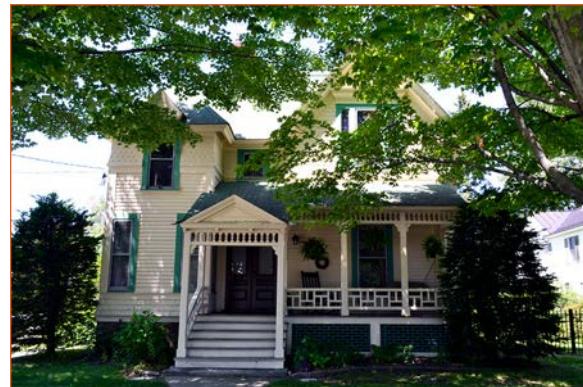
Built in 1881, this house on Pleasant Street is reflective of late 19th-century architecture found in the Pleasant Street neighborhood.

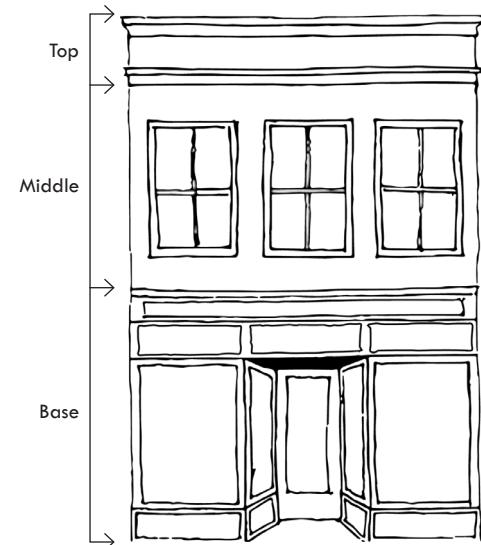
*Traditional multi-story buildings, especially mixed-use buildings follow a **hierarchy** that establishes a visually distinct based, middle, and top. The symmetrical window and transom fenestration creates a sense of architectural **rhythm**.*

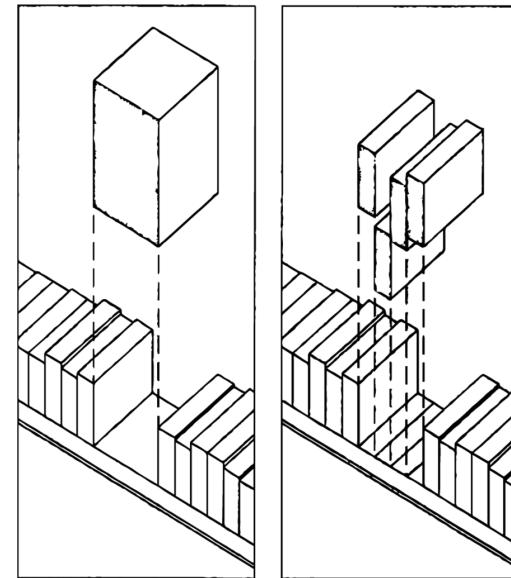
Infill development should be compatible with the massing of the surrounding context. The building on the left is out of scale with its surrounding context in comparison to the buildings on the right.
