# **MARE BROOK ASSESSMENT**

Technical Advisory Meeting # 2  
Town of Brunswick, Maine  
April 27, 2016

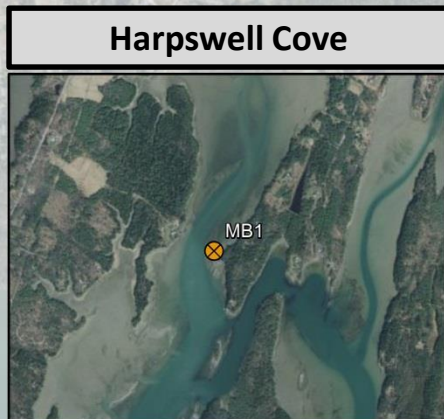
# MONITORING SITE MAP Mare Brook Watershed

- Sampling Sites
- Roads
- Drainage
- Waterbodies
- Watershed Boundary

Data obtained from the Town of Brunswick,  
the Maine Office of GIS and ESRI DigitalGlobe  
Projection: UTM Zone 19N  
Created by FB Environmental, April 2016

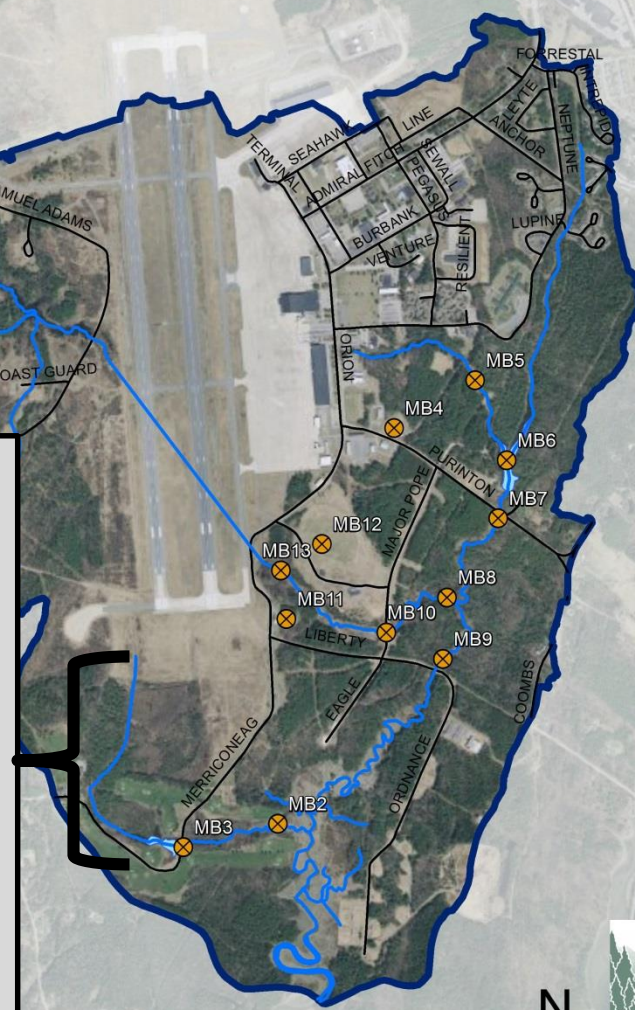
Macroinvertebrates

Data obtained from the Town of Brunswick,  
the Maine Office of GIS and ESRI DigitalGlobe  
Projection: UTM Zone 19N  
Created by FB Environmental, April 2016
