# MARE BROOK

## BASELINE & BEST MANAGEMENT PRACTICES REPORT

FB Environmental Associates  
97A Exchange Street, Suite 305  
Portland, ME 04101

**DECEMBER 2016**

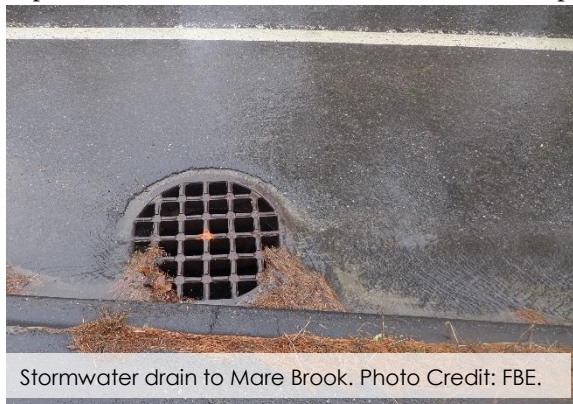
Stormwater drain to Mare Brook. Photo Credit: FBE.

**IMPERVIOUS COVER (IC)** such as parking lots, roofs, and sidewalks, results in runoff into the stream. Stormwater carrying dirt, metals, and other pollutants is conveyed directly from IC to the stream with minimal pre-treatment, causing increased erosion, sedimentation, increased temperature, and habitat degradation in the stream (CWP 2003).

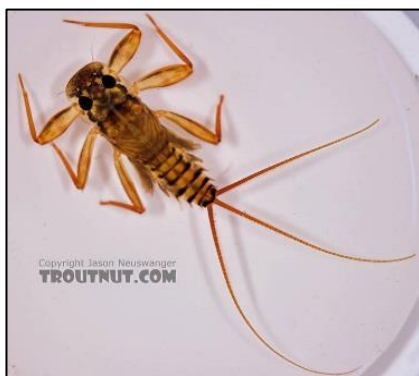
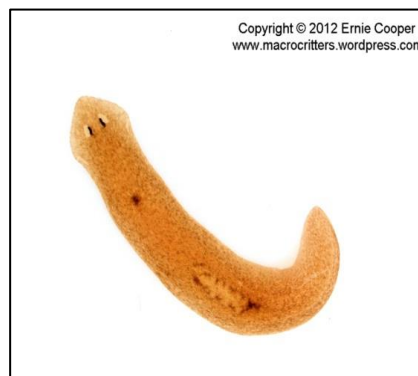
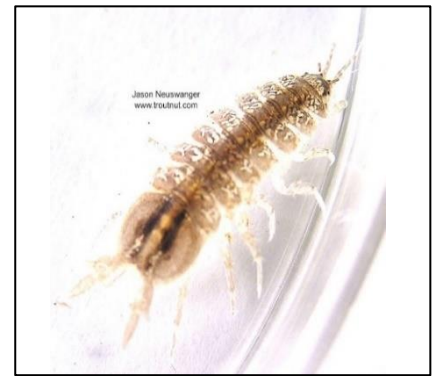
(Left) Mayfly (genus *MacCaffertium*) used in this study; (middle) Tubellaria flatworms found in Merriconeag Stream, and (right) Isopoda found in Mare Brook. Both the flatworms and isopoda were found to be predating on the mayflies. Photos from Maine DEP summary report.

Presence of Planarian flatworms suggests predation could have contributed to mayfly mortality at this site. Richards Drive saw a 36.7% survival rate with 82.2% of mayflies recovered. Lack of dead bodies suggests scavenging by isopods. Unfortunately, there was no survival in the reference enclosures on the Cathance River. Mayfly bodies were recovered so it is suspected that low dissolved oxygen levels ( $<2$  mg/L) were the cause of mortality. As a result, additional research is needed to make any conclusions from this study.

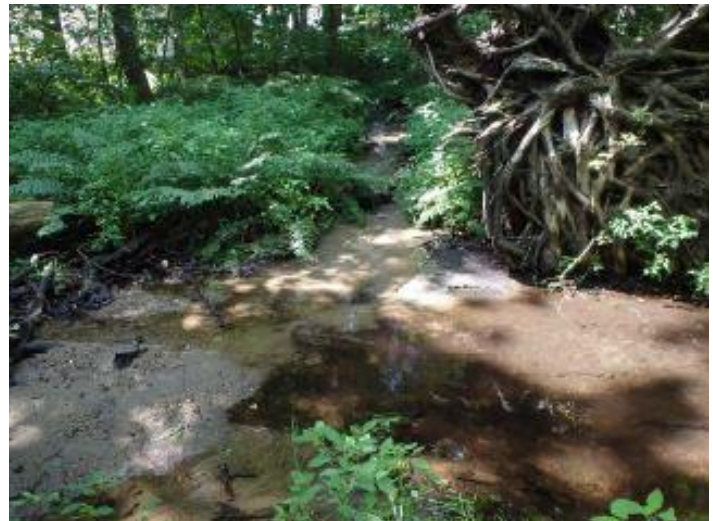
An example of excessive sediment supply in Mare Brook. Photo Credit: Stantec.

The geomorphic assessment identified sediment loading, stream channel alteration, and stream crossings as the major stressors to both Mare Brook and Merriconeag Stream. Mare Brook was divided into ten reaches and Merriconeag Stream into an additional two reaches. Each reach was rated on a scale from stable (lateral and vertical stability appears to be in equilibrium with natural channel processes) to unstable (lateral and/or vertical instability compared to natural processes). In total, four of the ten reaches were assigned “stable” ratings, one “stable to moderately unstable”, two “moderately unstable”, one “moderately unstable to unstable” and two “unstable”. The two unstable reaches were Reach 1 (Baribeau Drive to Barrows Street) and Reach 9 (Brunswick Executive Airport to Major Pope Avenue), both experiencing excessive sediment loading and channel alteration. The two reaches along Merriconeag Stream were both rated as “stable”. Dramatic increases in sediment load were noted at the outlet of the runway culvert.

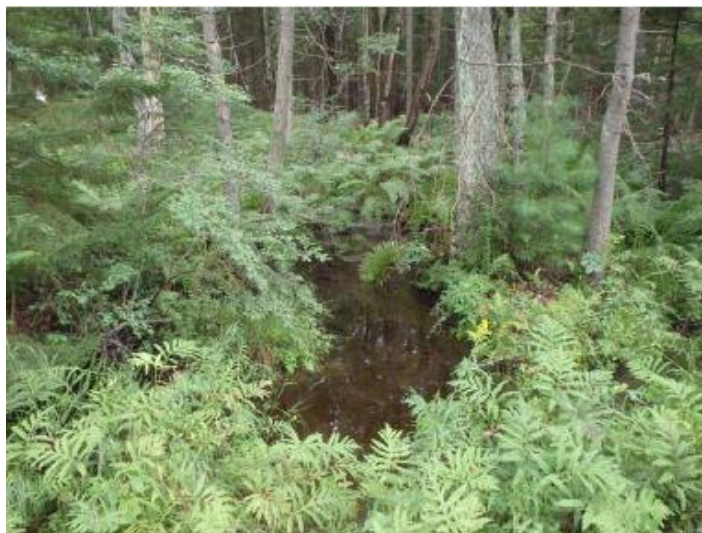
A potential vernal pool (PVP) identified by Stantec downstream of Major Pope Road.  
Photo Credit: Stantec.

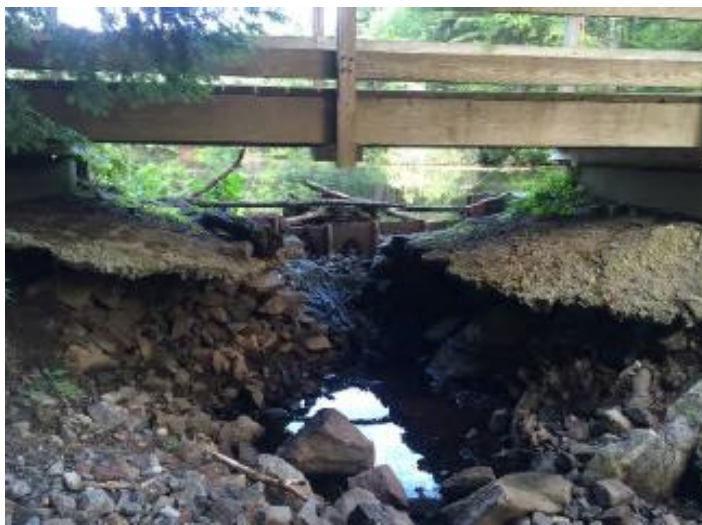
The Coffin Pond Spillway which was rated as “Not Passable” during the Fish Passage Assessment. Photo Credit: Stantec.

Finally, Stantec also completed a fish passage assessment evaluating all stream crossings along Mare Brook and Merriconeag Stream. It is important to note that this assessment was limited to the perspective of the target species (adult brook trout, *Salvelinus fontinalis*) and does not represent an assessment of other species or hydraulic conveyance in the stream. Six of the eleven stream crossings and Coffin Pond Dam were rated as “not passable” for upstream passage of adult brook trout. The remaining five culverts were in “good” condition. On Merriconeag Stream, the Beaver Pond Road crossing was rated as “not passable” and no passage is possible from the impoundment at Picnic Pond.
