Project No.: **21641 – Bunganuc Road Bridge No. 5219 – Bunganuc Road over Bunganuc Stream**

Subject: **Bunganuc Road Bridge No. 5219 – Conceptual Design Summary**

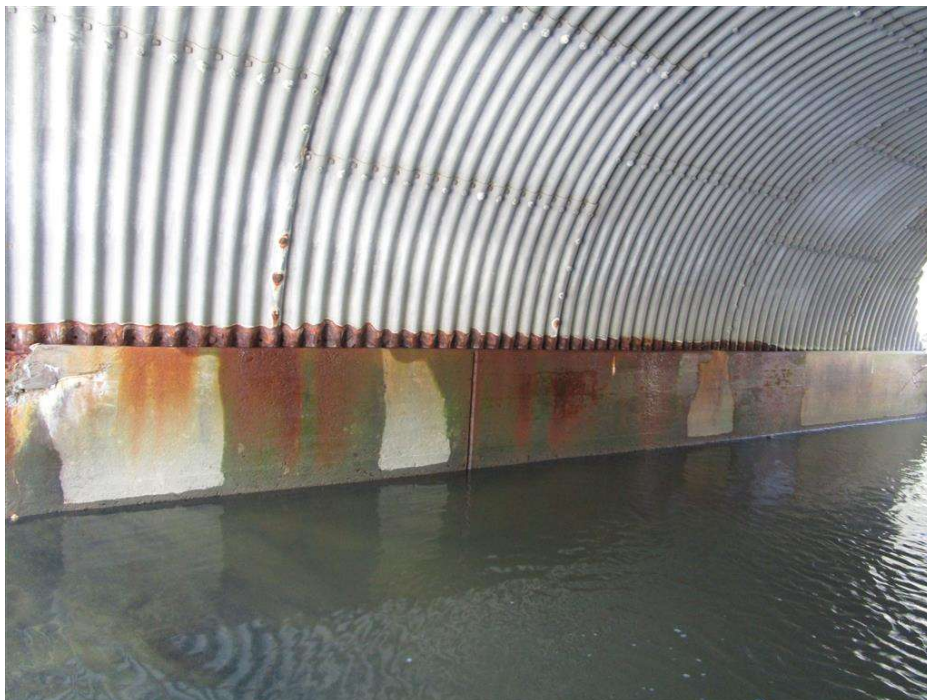
PHOTO 8

Description South culvert wall

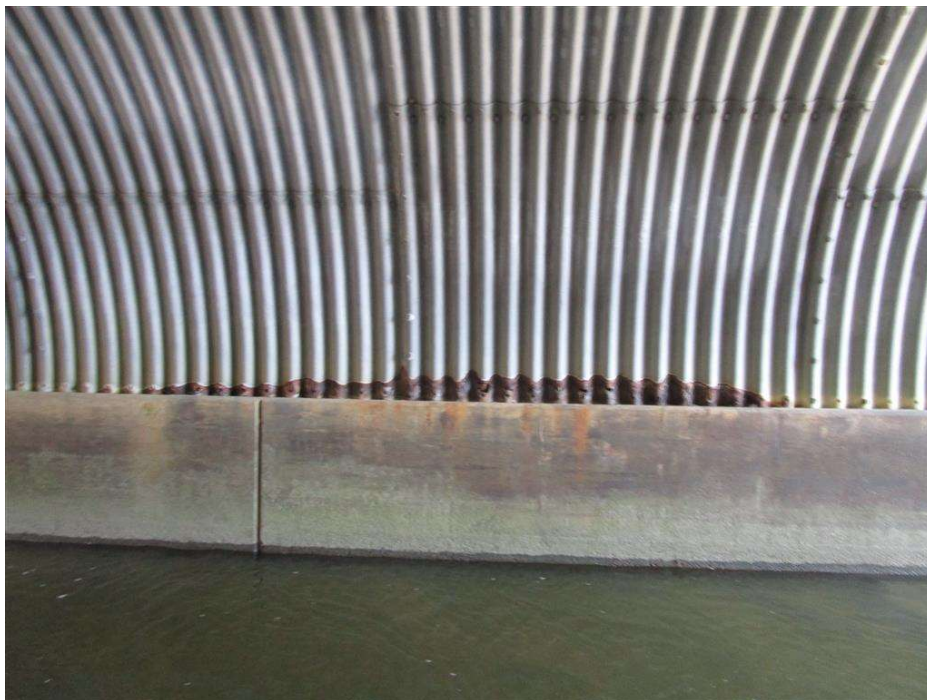
PHOTO 9

There is section loss at the spring line with backfill falling through 4"-5" holes for 6' on the north abutment in the middle of the culvert. There is heavy rust that continues for 3' on each side of this area.  
The south spring line has heavy rusting with scattered holes for about 60' starting at the downstream end. The rusting is just above the

Description Corrosion at spring line on north culvert wall

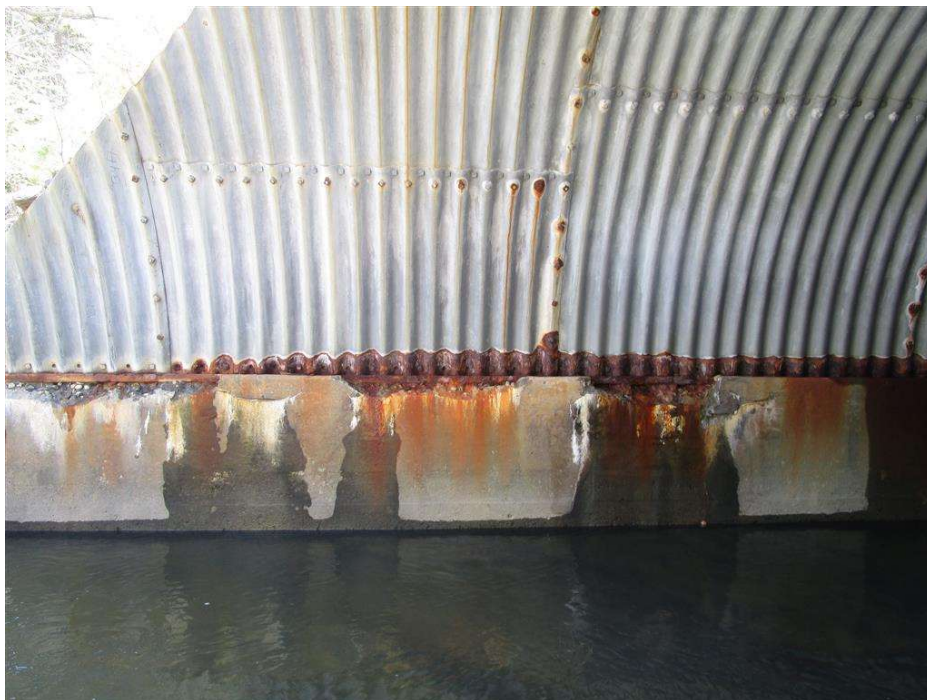
PHOTO 10

The top of the south concrete footing has spalled and is exposing the spring line for approximately 16' at the downstream end.

One spall in the middle of the south footing allows backfill to leak out from under the spring line.

Description Spalls and leaking spring line at south culvert wall

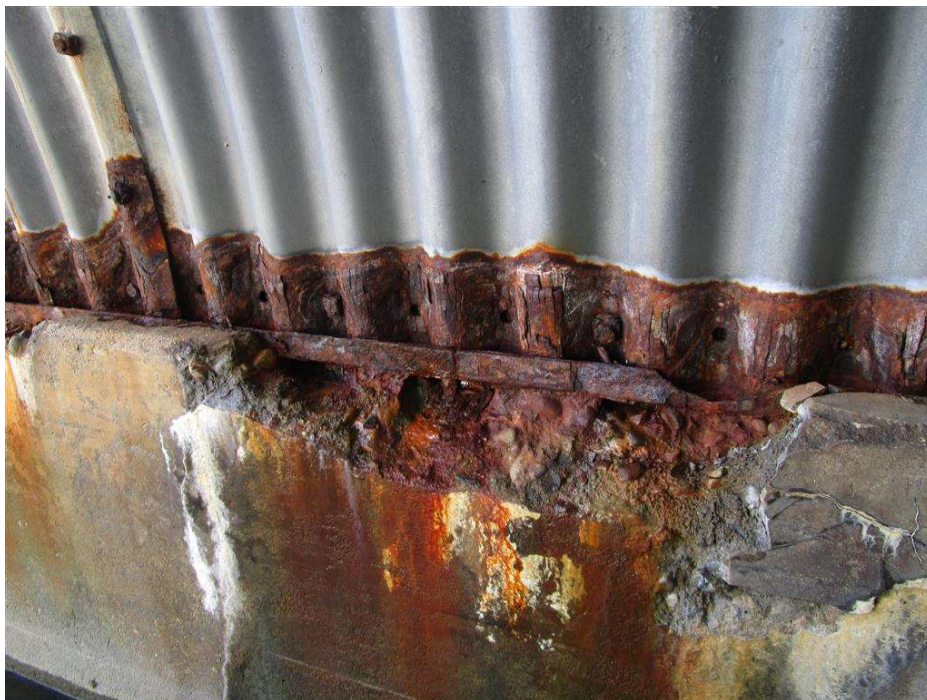
PHOTO 11

Description Spall with exposed spring line and backfill leakage

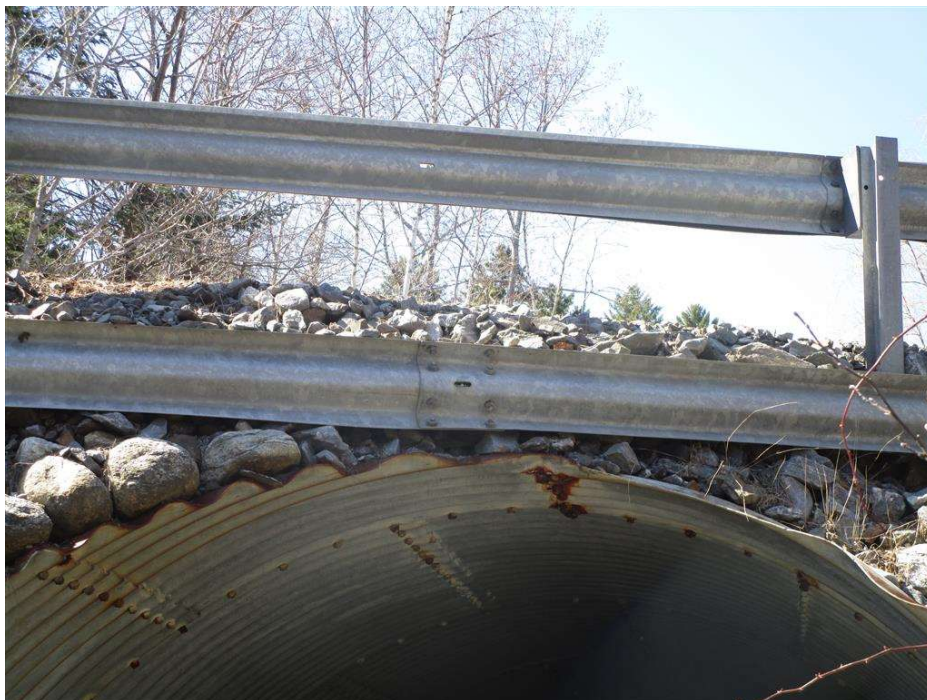
PHOTO 12

There is a 6 in wide x 3 ft long section of corroded bolts at the top middle of the outlet.

Description W-beam headwall and bolt corrosion at top of culvert (east side)

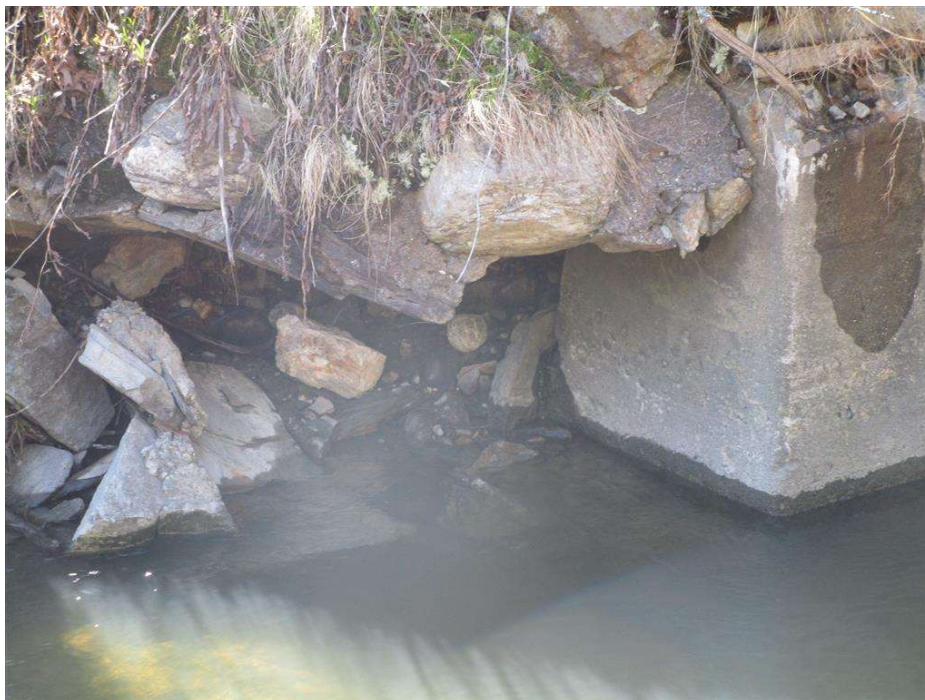
PHOTO 13

Description Large void under riprap at the southeast corner

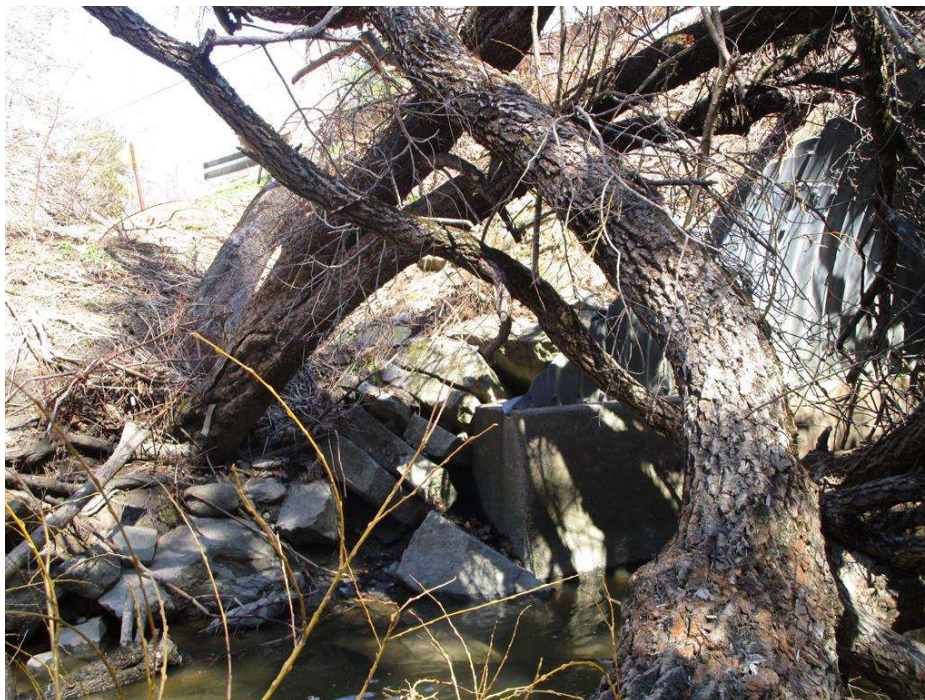
PHOTO 14

Description Slumped stone protection and fallen tree at the northwest corner

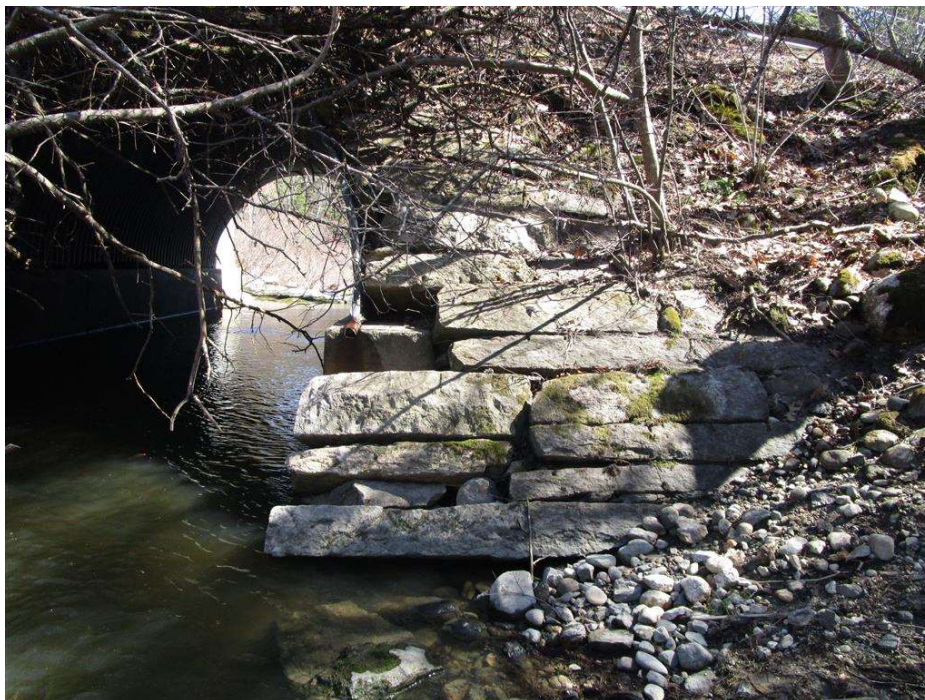
PHOTO 15

Description Stacked stone protection at the southwest corner

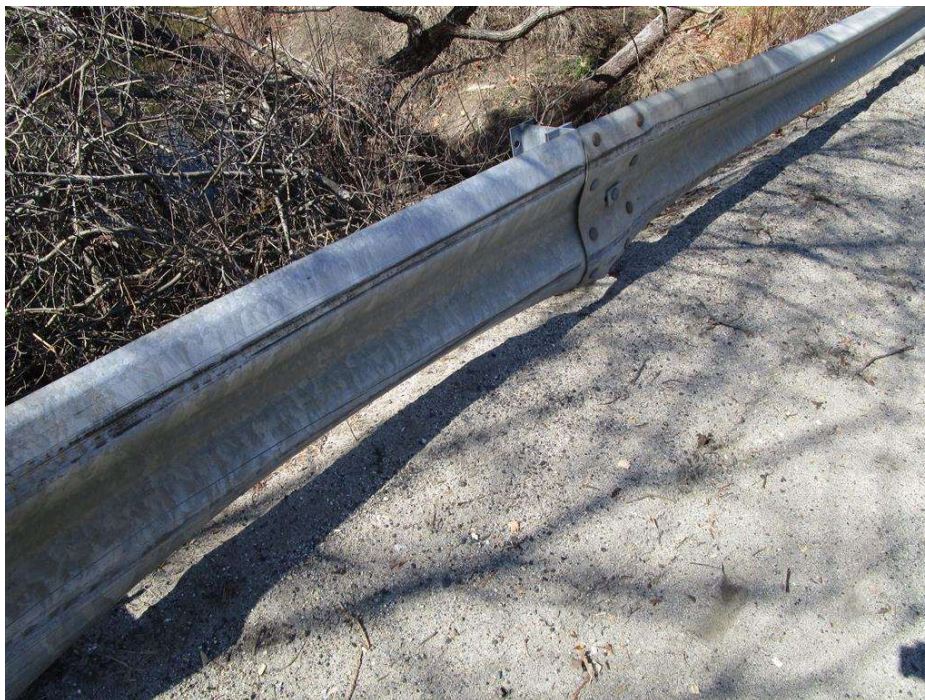
PHOTO 16

Description Guardrail overfill on west side of road

Standard highway guardrail was provided on both sides of Bunganuc Road along the bridge approaches and at the bridge to protect errant vehicles from leaving the road. Guardrail posts were placed at the top of the slope with insufficient supporting “guardrail berm” soils and embankments of 1 to 1 or steeper directly behind the posts. The existing guardrail exhibited signs of moderate impact damage in spot locations from plows and vehicles along both sides of the roadway. Additionally, the guardrail and terminals did not appear to meet current MASH requirements for guardrails and should be replaced.
