# Mare Brook Macroinvertebrate Enclosure Study

## *Introduction*

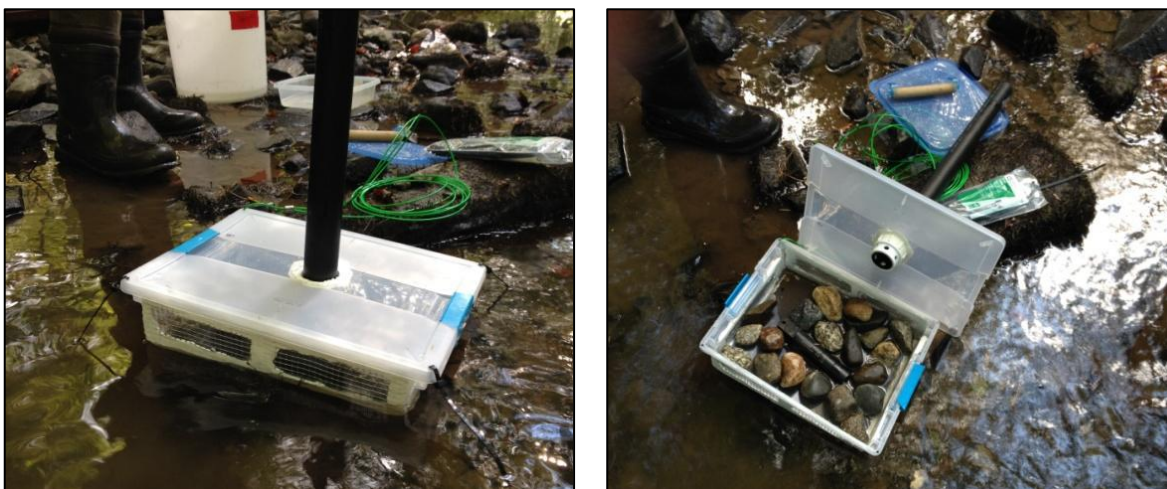
**Figure 1. In-stream chambers used to standardize physical habitat conditions between sites. The chambers are filled with cobble-sized rocks to provide suitable macroinvertebrate habitat. They have mesh openings on all sides to allow water to flow through the enclosure. The black pipe on the top of the chamber allows access for a water quality probe to monitor conditions inside the enclosure.**

The chambers were made from 11" x 14" x 3.5" plastic boxes. Holes were cut along each side of the boxes to maximize the flow of stream water through them. The holes were covered with window screen (inside) and ¼" hardware cloth (outside) to keep macroinvertebrates inside and strengthen the chambers. A tube was attached through the lid so that a water quality meter could be lowered inside to monitor in-chamber water quality conditions (Figure 1).

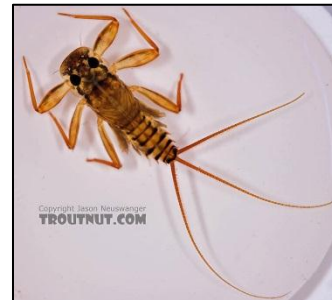
**Figure 2.** The mayfly (genus: *MacCaffertium*) used in the study.

**Study organisms** – A particular genus of mayfly (*MacCaffertium*; Figure 2) was chosen to stock inside the chambers due to their commonness in Class B streams in Maine and their known ubiquity at a particular stream location (Douglas Brook in Gorham, ME). All of the mayflies used in the study were collected on the morning of deployment (Figure 3). They were kept alive during transport to the study sites in a bucket of cool water with a running aquarium aerator.

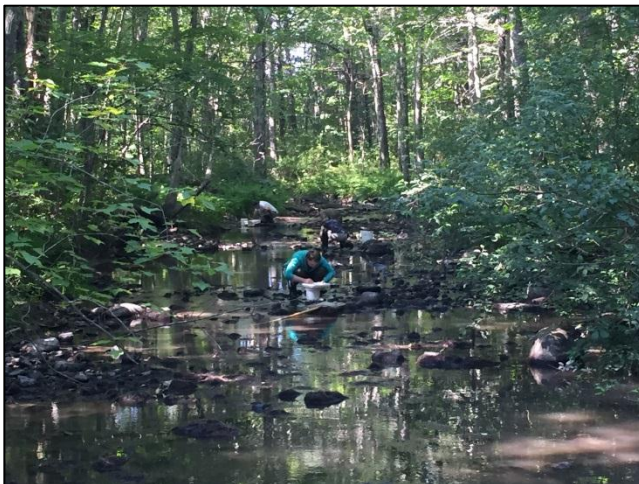
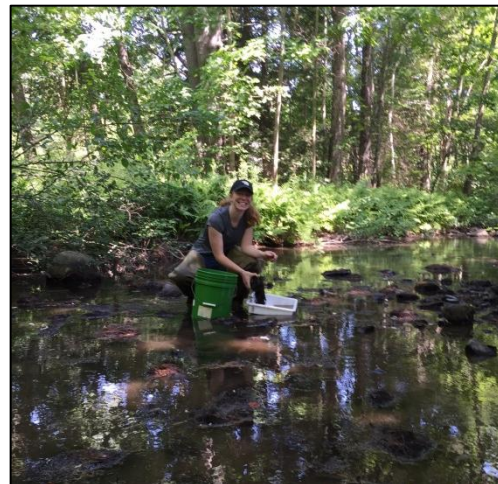
**Figure 3.** Collecting mayflies at the study stream.

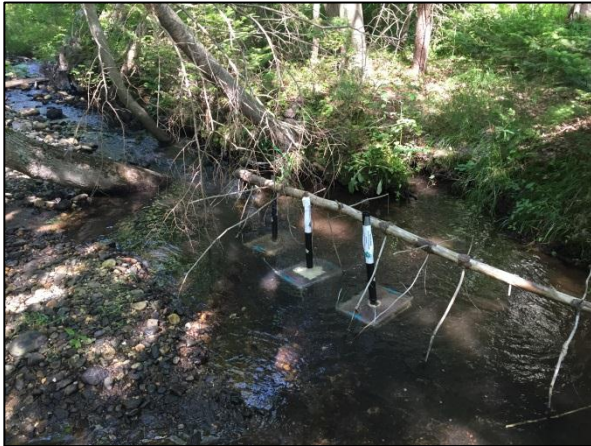
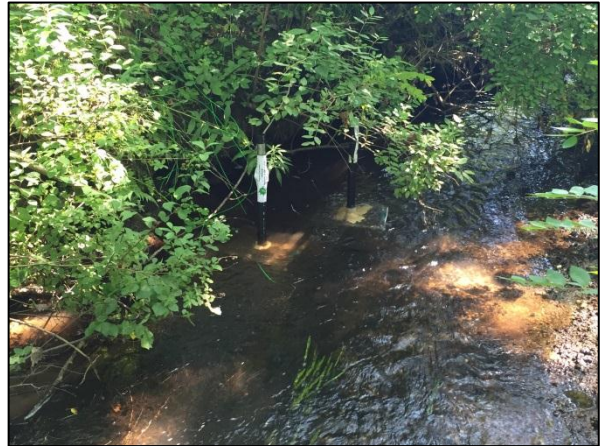
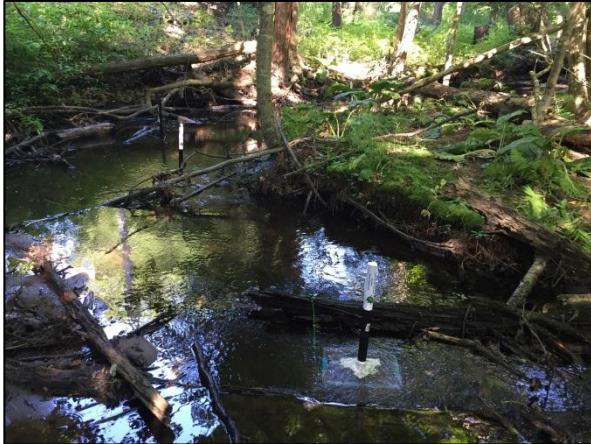
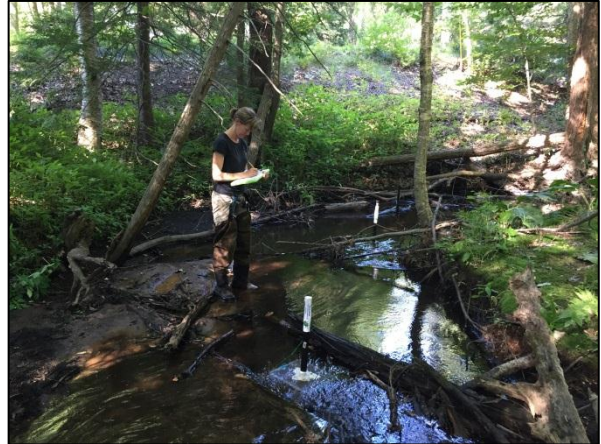
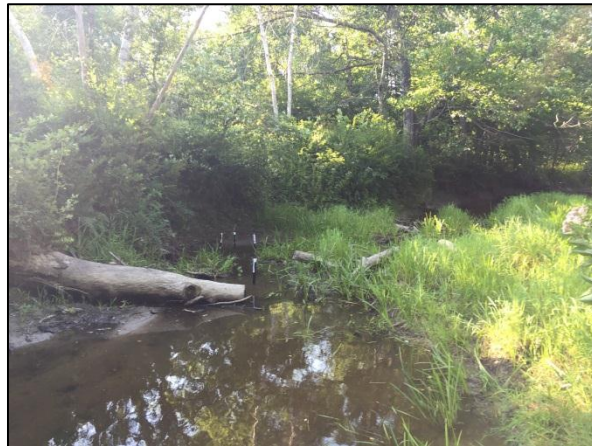
*Merriconeag Stream below Purinton Crossing (S-330)*

*Mare Brook along Richards Drive (S-1064)*

*Reference Stream: East Branch Cathance River (S-859)*

**Figure 3. Placement of chambers at each of the three site locations.**

**Chamber Deployment** - Chambers were deployed at all three sites on August 5<sup>th</sup>, 2016. They were left in the stream for seven days and were retrieved on August 12<sup>th</sup>, 2016. This was a hot dry week with daily air temperatures near 85°F. A negligible amount of rain fell in the area during the deployment period (0.09" on August 10<sup>th</sup>). Five chambers were deployed at each of the three sites (Figure 4), all with 10 mayflies in each. Daily water quality measurements (water temperature, dissolved oxygen and specific conductivity) were recorded to check for variation between stream conditions and chamber conditions (Table 1). Electronic datasondes were also deployed at each site to record continuous dissolved oxygen and temperature data (Figure 5).

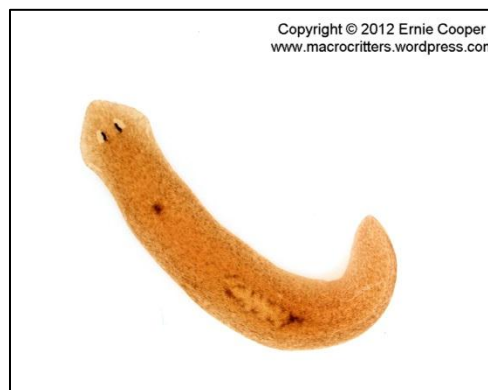
**Figure 5. Tubellaria flatworms (genus *Planaria*) were found in abundance in the Merriconeag Stream chambers. Planarians are known to eat living and dead animals, and may be the reason so few mayflies (or mayfly parts) were recovered from these chambers.**

No live mayflies were found in any of the five chambers. On average, only 2.8 dead mayflies were recovered from each, indicating a substantial loss of mayflies from these chambers. Planarian flatworms (Figure 5) were abundant inside these chambers upon retrieval; the flat worms were likely scavenging and/or predating upon mayflies which could explain the low numbers recovered. Mayfly parts were not as abundant as in the reference stream chamber, providing further evidence that predation or scavenging was occurring. These results make it unclear how many mayflies potentially died due to stream conditions alone. Dissolved oxygen was slightly lower in the chambers relative to stream but not enough to cause concern.

The invasion of other taxa (flatworms in Merriconeag Stream and Isopoda in Mare Brook) into the chambers makes it difficult to determine if mayfly death or disappearance was due to stream conditions or predation, or both. The intent to keep mayflies inside, other animals outside, and water flowing freely through the chambers is difficult to implement. There has been success with this chamber and study design before, but Isopods and flatworms were not observed to be an issue in the previous study streams.

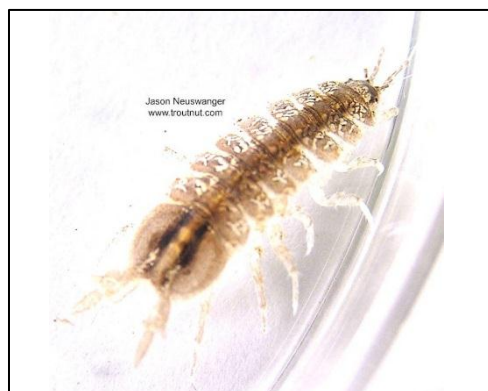
**Figure 5. Isopoda (a crustacean that can be found in fresh or salt water, also on land) were found in abundance in the Mare Brook chambers. Isopods are known to eat living and dead animals, and may be the reason so few mayflies (or mayfly parts) were recovered from these chambers.**

Some survivorship was observed at this site: 36.7% of original 10 mayflies were still alive at retrieval, while 82.2% of mayflies remaining in the chamber were still alive). In these chambers, Isopods were found to be abundant. As in the Merriconeag Stream chambers, there is high likelihood that the isopods were scavenging on mayfly bodies and parts since there were almost no signs of dead or decomposing mayflies in these chambers. Dissolved oxygen was slightly lower in the chambers relative to stream but not enough to cause concern.
